# SEEND ROAD SAFETY INITIATIVE

(Version 2.1 – February 2017)

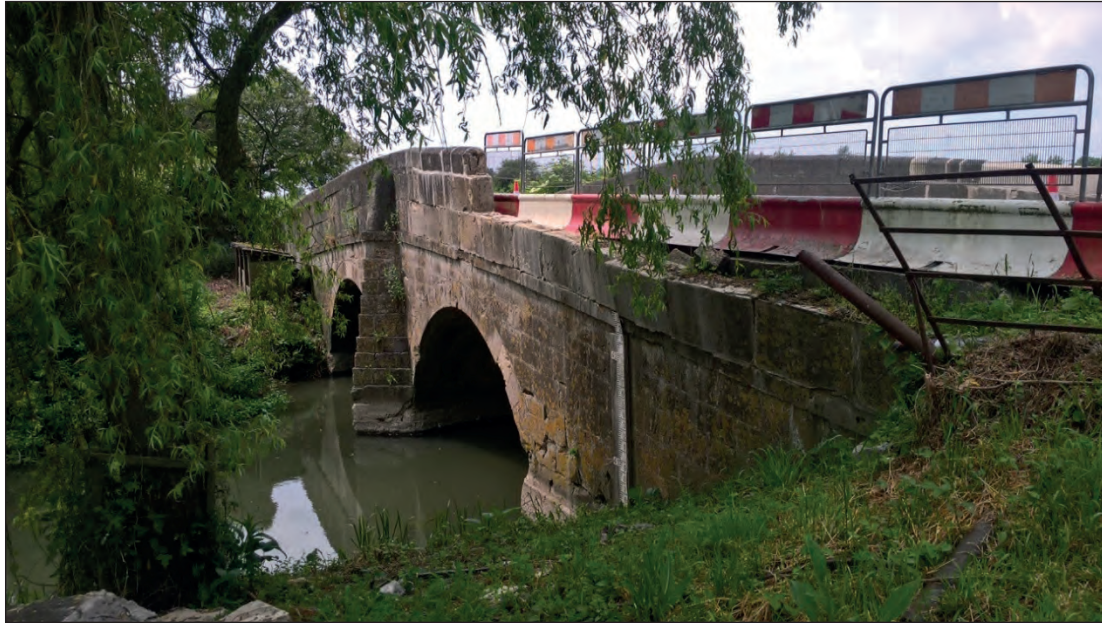
**Figure 6 - Damage to Grade II listed Baldham Bridge - Under Repair (1)**

This structure (Grade II listed) has been the victim of substantial and frequent damage over a number of years. Despite this, the authorities have deemed the bridge capable of handling the current freight traffic levels and further action, in respect to weight/speed limits on the bridge has been ruled out by Wiltshire Council.

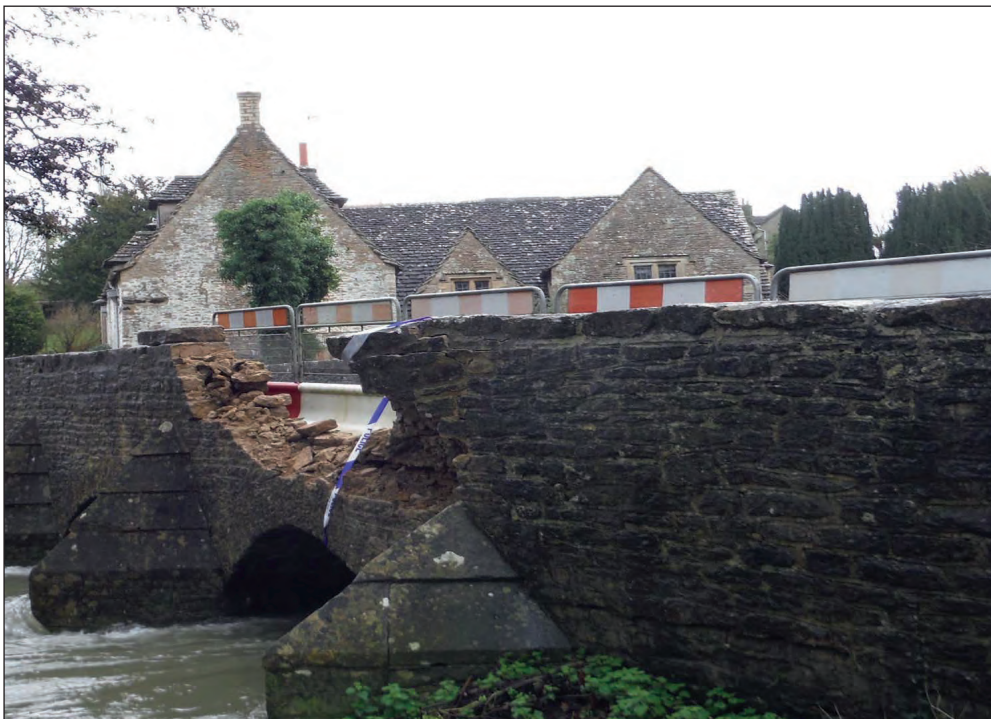
**Figure 7- Damage to Baldham Bridge - Under Repair (2)**

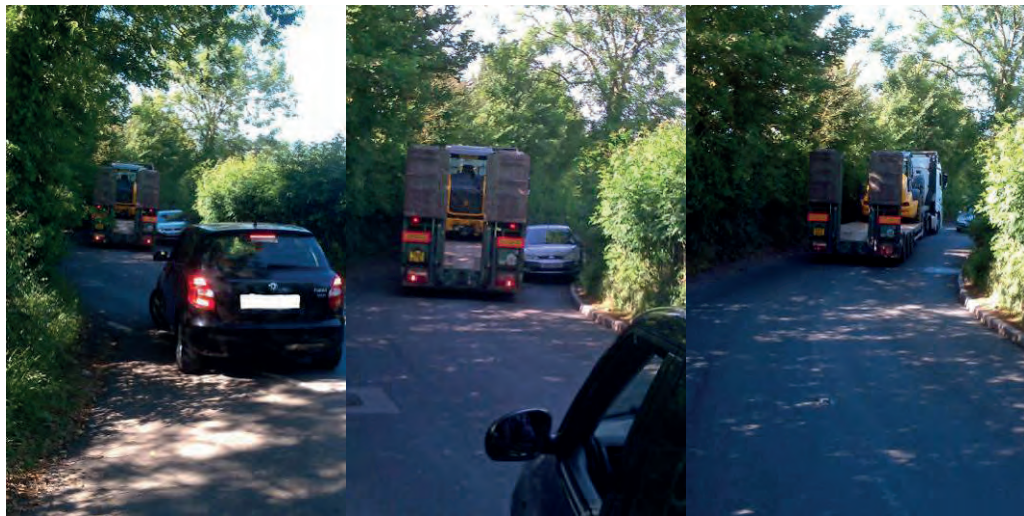
The lorry, a white 2012 Mercedes Actros 2545ls Tractor (registration GX12 KCG), left the scene without the driver leaving any Driving Licence or Insurance details<sup>10</sup>.

**Figure 10 - Bollands Hill Blocked to Traffic**

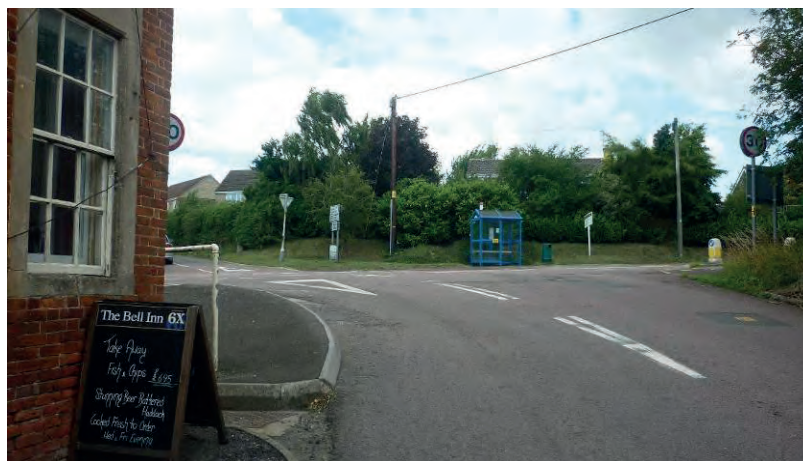
The approach to the cross-roads is a particularly good example of where the signs are woefully inadequate. Several recent accidents have occurred here (see Figure 12 - Bell hill crossroads (Approached from the South)).

Figure 12 - Bell Hill crossroads (Approached from the South)

The 30mph speed limit warning signs are sited 22 ft. from the A361 and only become visible when a motor vehicle is within 70 ft. of this main road.

At least two accidents have been caused within the last 6 months as a result of vehicles failing to stop in time as they approach the main road.

Attention to the sign deficiency highlighted at the Bell Hill cross roads and Bollands Hill.

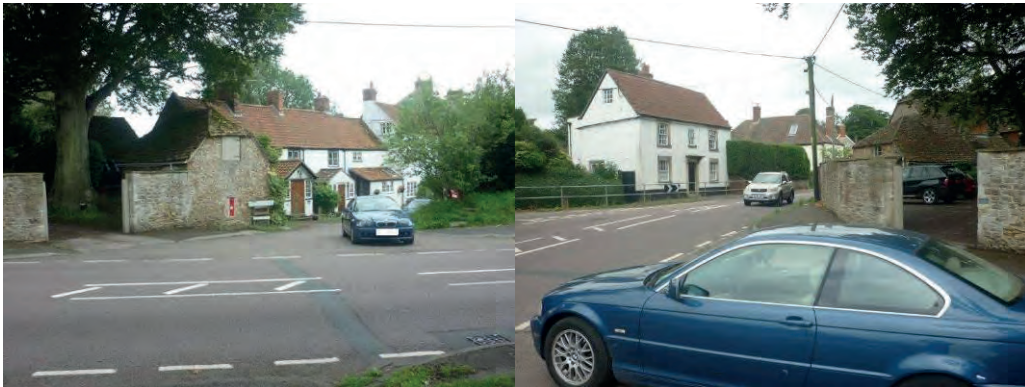
**Figure 13 - Exiting from Weavers Cottages**

Whereas entry to the road can be, at best, difficult, exiting from Weavers Cottages is hazardous: particularly if vehicles are exiting the 'pinch point' with vehicles approaching from the East at anything above 30mph with a stopping distance of 75 feet or more. The visibility to the East at this exit is 70 feet. Opening the driver side window and listening for oncoming traffic is an essential requirement.

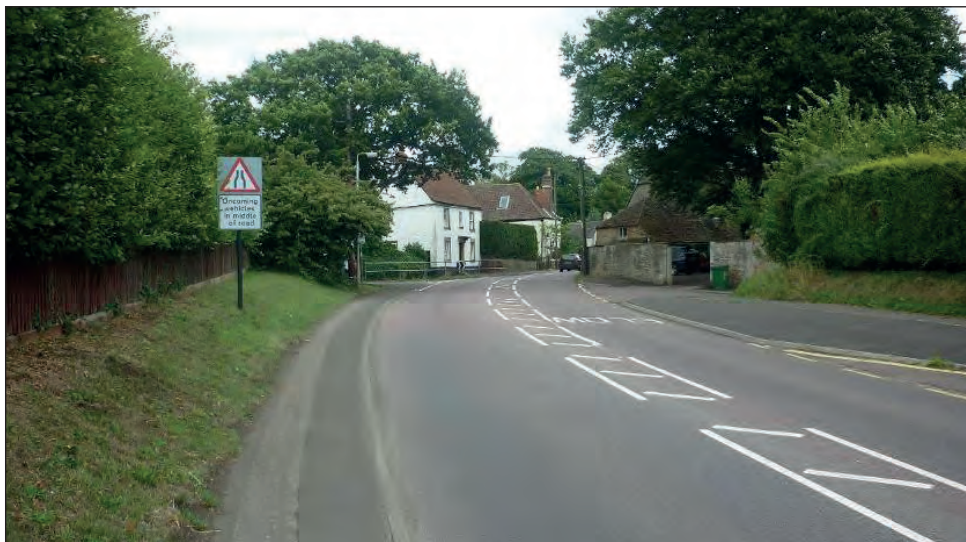
**Figure 14 - Approaching from the West**

Figure 14 shows the view when entering Seend, travelling East on the A361, from Trowbridge. The 'pinch point' is where the railings are visible on the left. This narrow footpath is the regular route for pupils from the village to reach the school.

On the right are Weavers Cottages where vehicles leaving to join the A361 have less than 70 feet of visibility from the East.

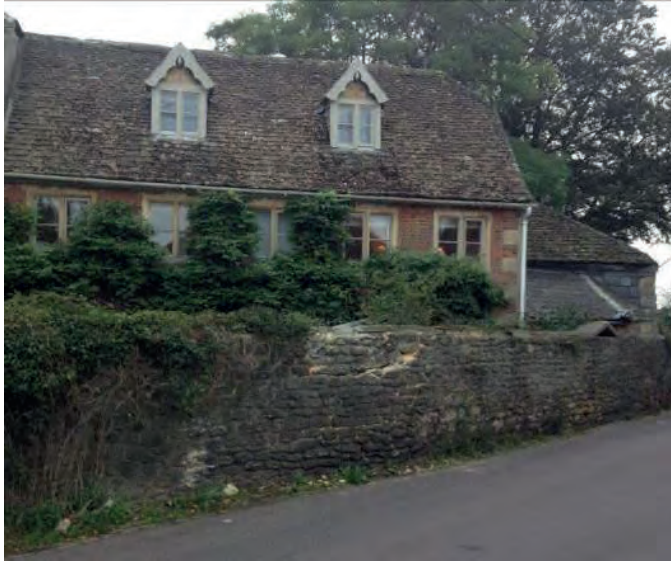
The 'pinch point' is a particularly hazardous location at the West end of the High Street.

Although it acts as a natural traffic calming point, the speed at which vehicles approach this road restriction means that making contact with each other, or the wall/railings to either side highly likely. This may result in damage to the vehicles, residential property, roadside furniture or, in the worst possible case, death or injury.

**Figure 15 - Damaged wall at the 'pinch point'**

Safety measures at the 'pinch point' are therefore required, whether they embrace an introduction of a 20 mph limit in this area or a solution as outlined in Section 11 (Recommendations).

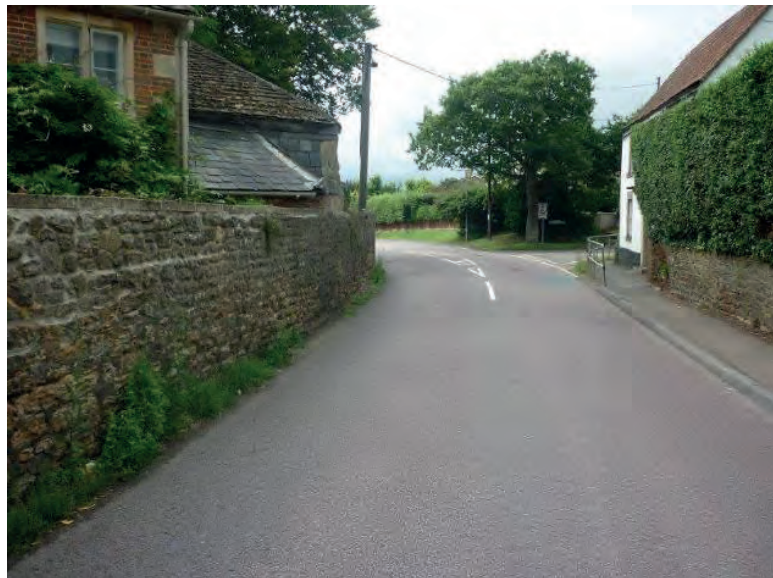
**Figure 16 - Approaching the 'pinch point' from the East**

It is noted that the road is too narrow for a lorry and a car (or another lorry) to pass together at this point (width 4.9 metres) without one of the vehicles having to mount the pavement endangering pedestrians.

The railings (that have been frequently damaged) in the bottom-right picture indicate the entrance to School Lane. This is the route to school for children and their parents.

If an HGV or bus driver cannot see 59m to an oncoming vehicle at the 'pinch point' (see 2.4.2.2) then the geometry fails at a very basic level. Even if they *can* see that far, reference to the Highway Link Design Manual of the Highways Agency indicates that the distance should be 65m, this being almost a rural road with a low alignment constraint (Ac) apart from at the 'pinch point'.

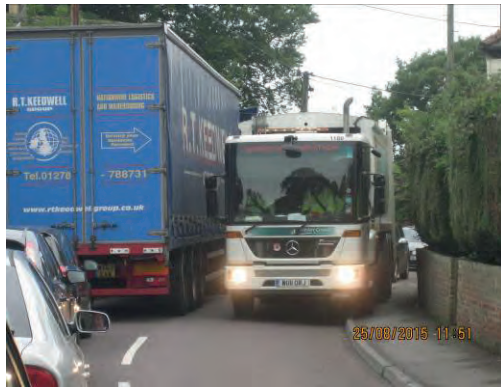
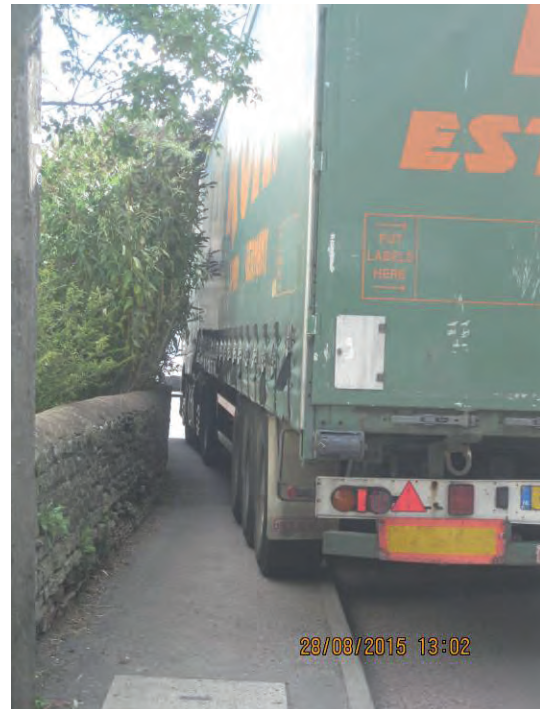
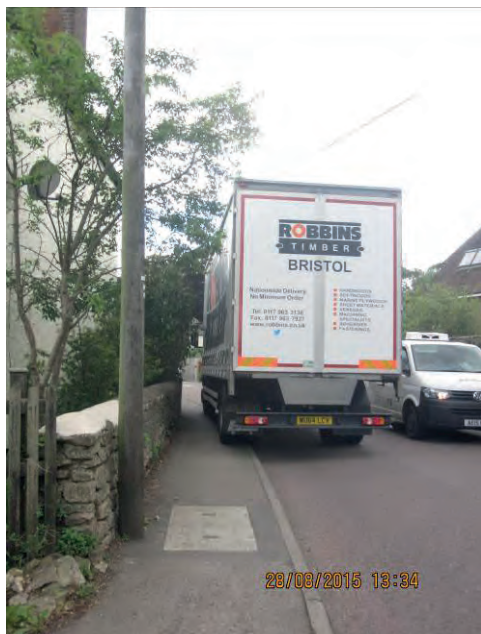
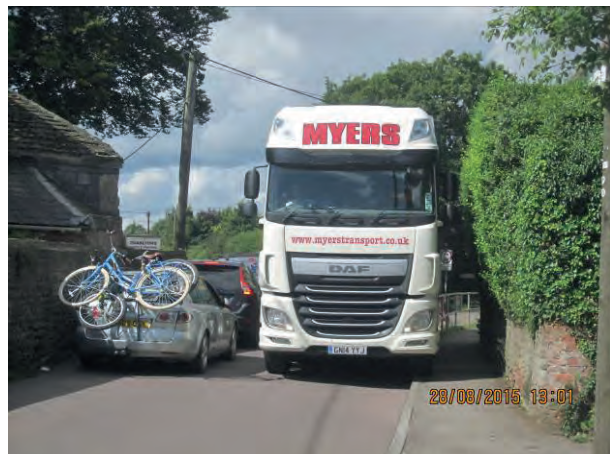
Figure 17 illustrates HGV dangers to pedestrians at the ‘pinch point’.

Figure 17 – ‘pinch point’ pavement

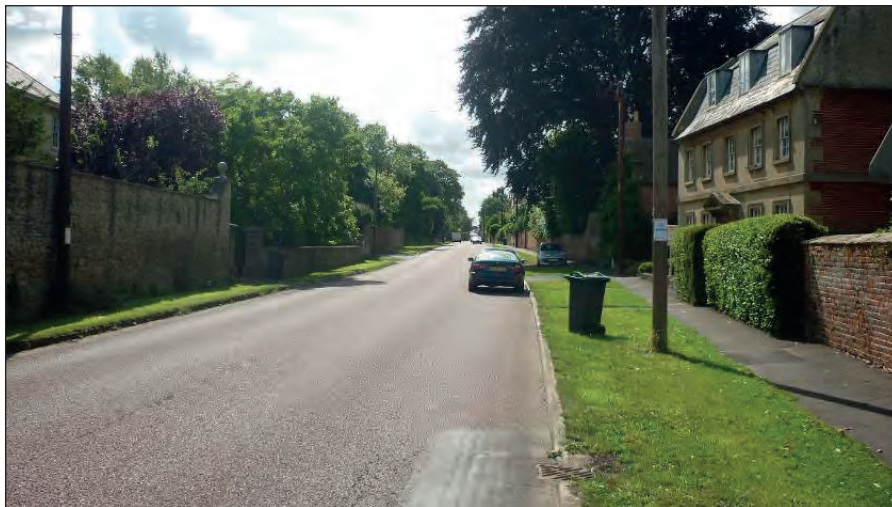
Figure 19 - Eastern end looking West

Figure 19 shows how inviting the three lane width of the High Street is to motorists leaving the bends at the top of the hill from Seend Fork: especially those that remain unaware of the 30mph zone.

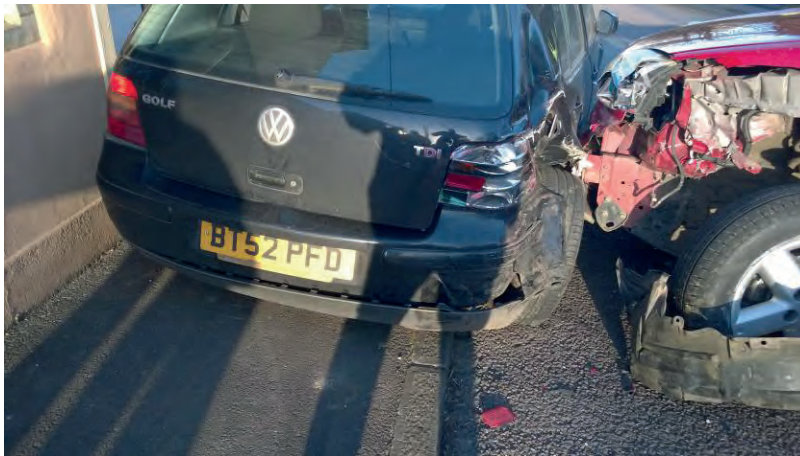
**Figure 20 - March 2015 – Collision**

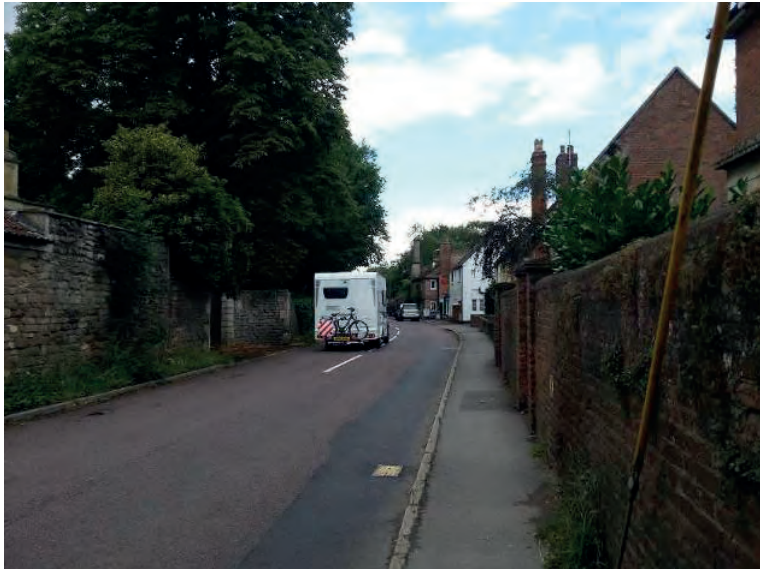
It should be noted that the road and footpaths here are narrow and even light vehicles such as the campervan in Figure 21 are crossing the centre road markings, thus pushing oncoming vehicles towards the footpath next to the opposite lane. The visibility splay dimensions are way below desirable standards for pedestrians at this point.

**Figure 21 - Crossing to the Church (Looking West)**

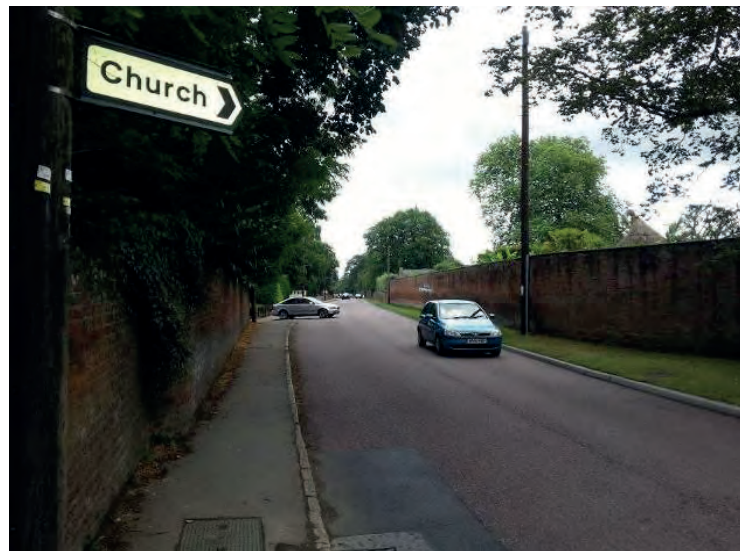
**Figure 22 - Crossing to the Church – (Looking East)**

Figure 22 and Figure 24 clearly show some of the obstacles that make the use of the grass verge on the South side of the High Street impractical.

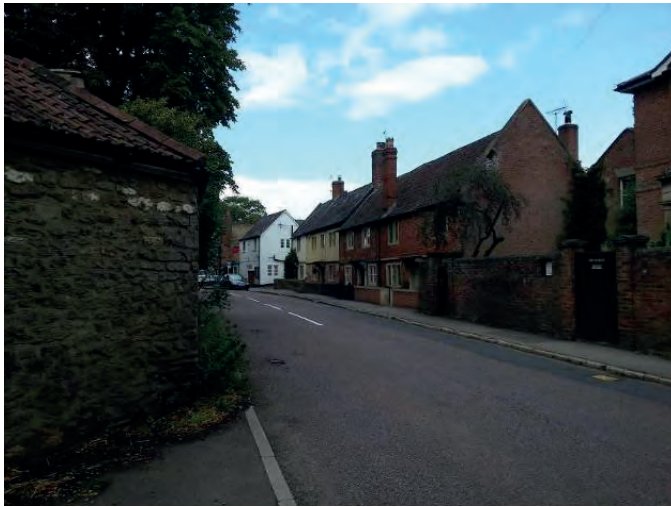
As can be seen, the view to the West is particularly hazardous as the view is shortened by the wall and the bend towards the Post Office.

**Figure 23 - From the Church (Looking West)**

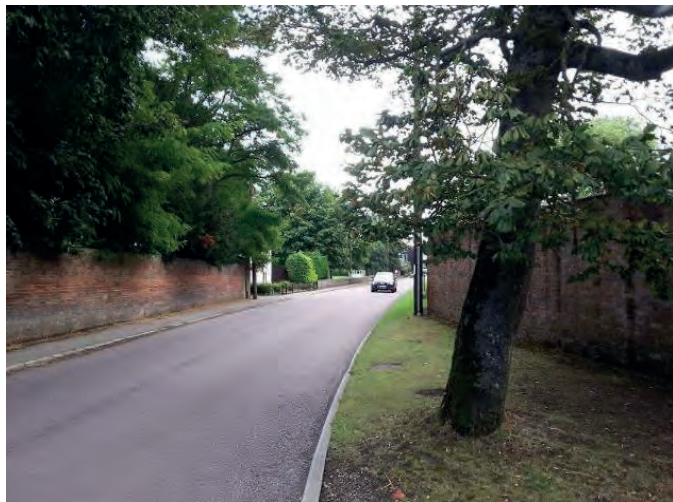
The view Eastwards is also partially blocked by the walled garden of The Manor.

**Figure 24 - From the Church (Looking East)**

There are no footpaths on the South side of the High Street and there are a number of obstacles (including signs and telegraph poles) that make the use of the narrow grass verge hazardous to pedestrians who might otherwise use this as a possibility to give them a better view of oncoming traffic. As previously stated, the visibility splays at this point are inadequate for pedestrians, as they also are for vehicles exiting Rusty Lane.

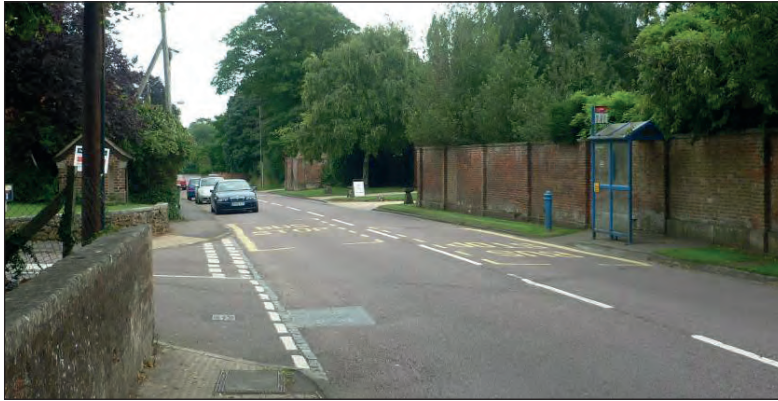
**Figure 25 - The High Street Bus Stops**

Two bus stops in the centre of High Street straddle the junction with The Lye.

It is also hazardous for drivers of cars trying to exit The Lye onto the High Street.

The location of the South side bus stop goes against good practice. If possible it should be relocated to the West with footway widening. See 11 Recommendations.

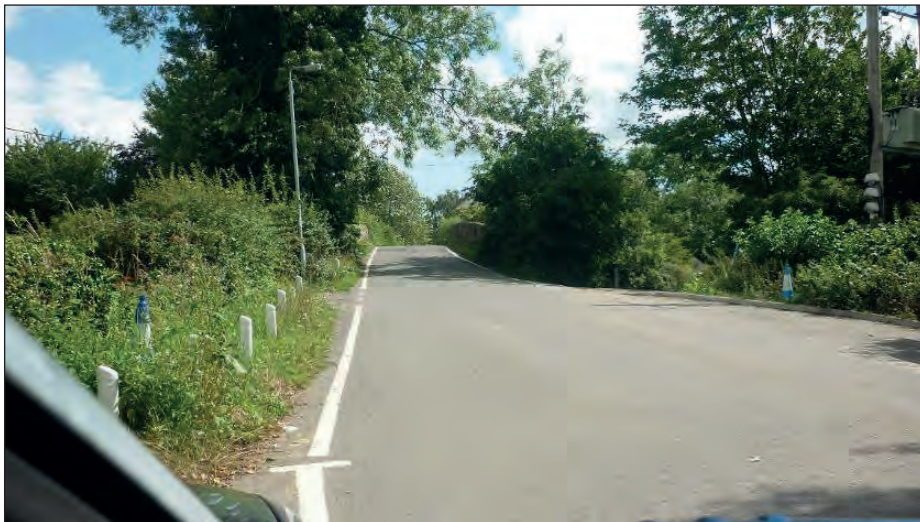
Figure 28 - Spout Lane Canal Bridge (from the North)

Figure 28 shows the view as you approach the canal bridge from the North. There are no speed restrictions or warning of the single carriageway.

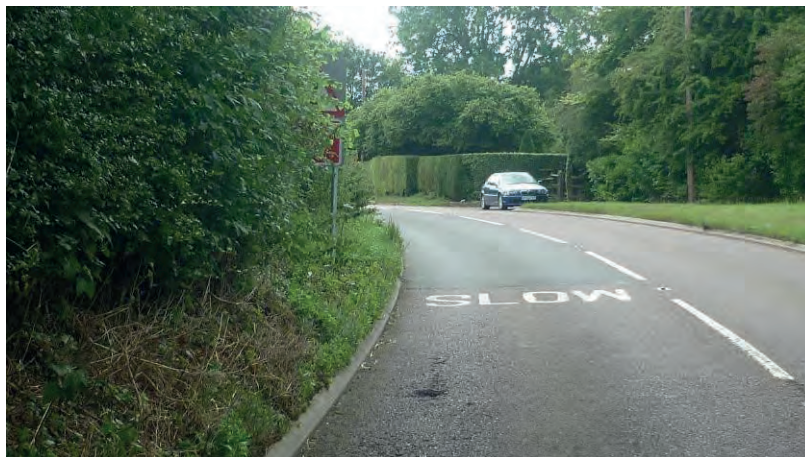
Figure 31 - Approaching the bends by Inmarsh Lane

Figure 31 shows hidden signposting as you approach Inmarsh Lane on the left entering the bends at the Eastern approach to the High Street.

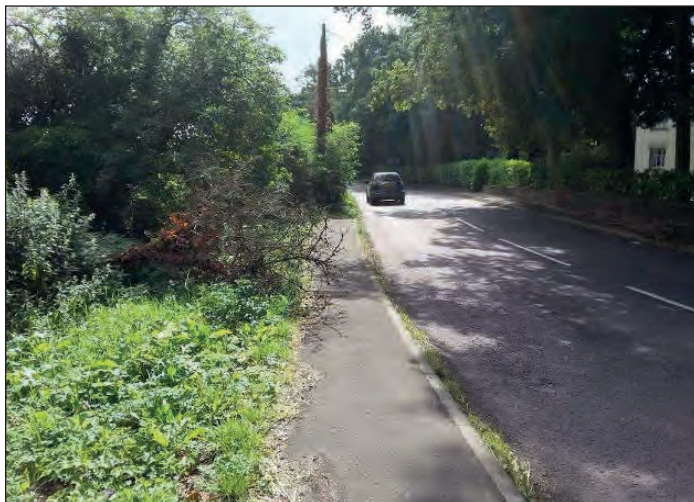
Figure 34 - The footpath looking East

Figure 34 shows the view of the footpath if walking from the village on the North side of the road and to the point that the path crosses to the South side. At the time the picture was taken the footpath has also been partially blocked by a fallen branch.

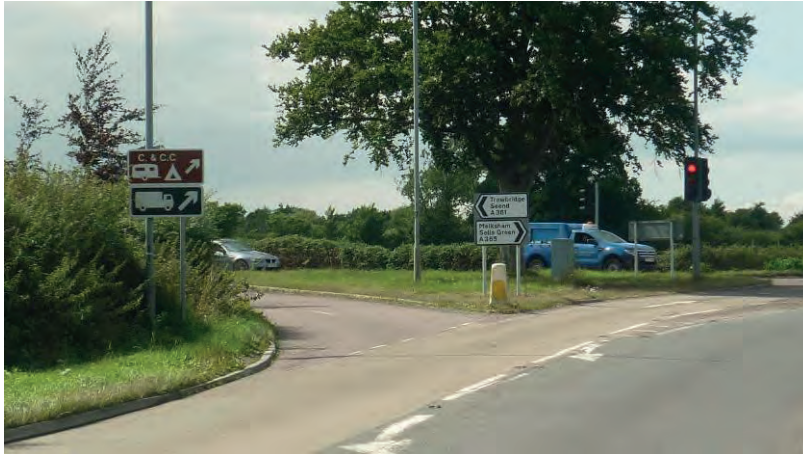
Figure 35 - Approaching Seend Fork from Devizes

Wiltshire Council (See section 11) signs situated on the A365 approaching Seend Fork are ineffective in directing HGVs in accordance with the Wiltshire Council Freight Route Policy. The signs at the traffic lights are confusing and the presence of a filter lane encourages traffic to turn left rather than wait at the traffic lights. Furthermore, two signs are contradictory, one routes HGVs to Westbury and Trowbridge via A365 and a later one signals traffic to Trowbridge through Seend Village via A361.
