# SEEND ROAD SAFETY INITIATIVE

(Version 2.1 – February 2017)

Seend Traffic – A361 in 2016

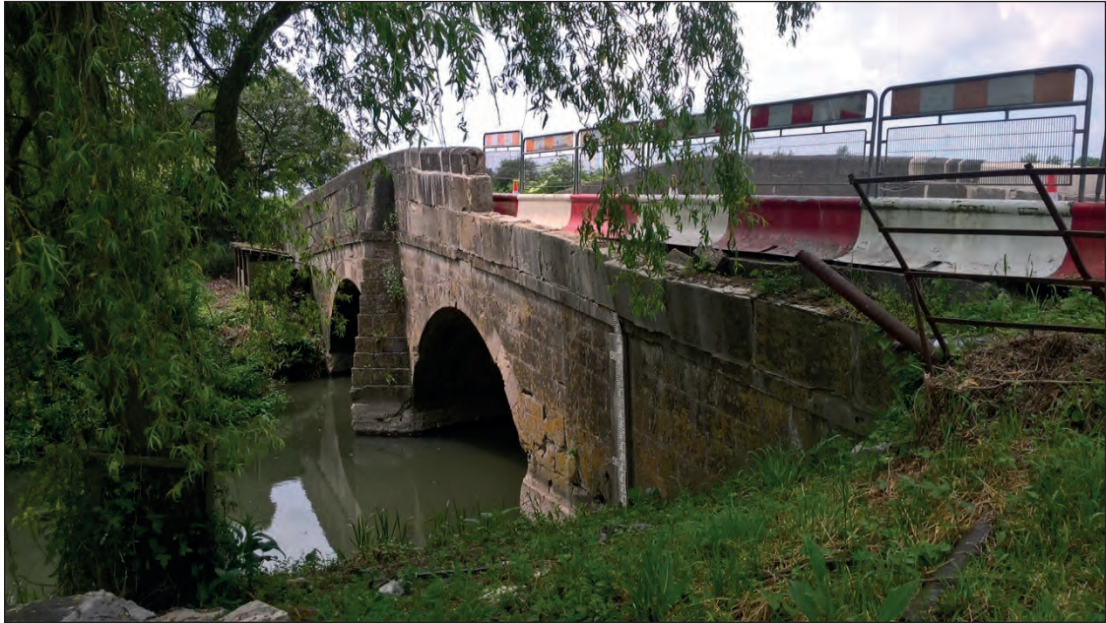
**Figure 6 - Damage to Grade II listed Baldham Bridge - Under Repair (1)**

This structure (Grade II listed) has been the victim of substantial and frequent damage over a number of years. Despite this, the authorities have deemed the bridge capable of handling the current freight traffic levels and further action, in respect to weight/speed limits on the bridge has been ruled out by Wiltshire Council.

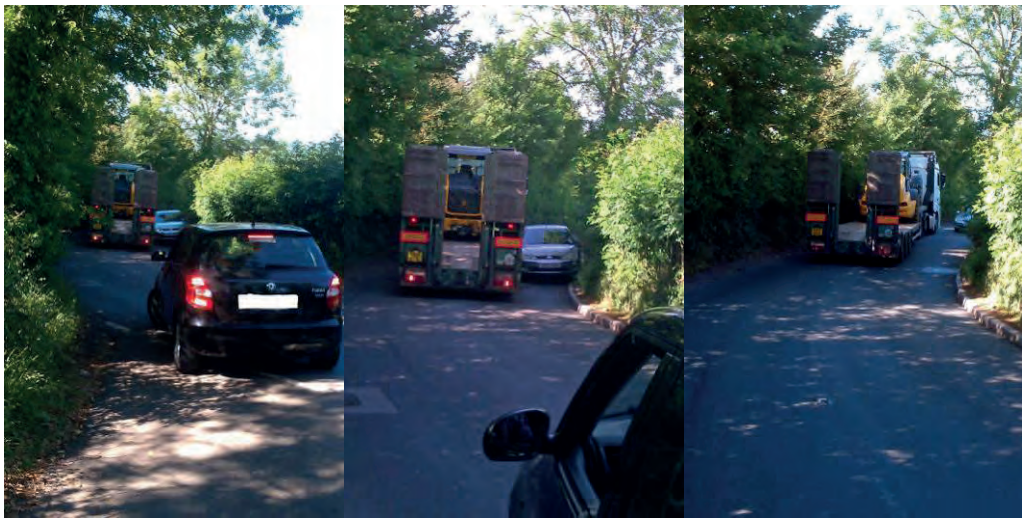
**Figure 10 - Bollands Hill Blocked to Traffic**

The lorry, a white 2012 Mercedes Actros 2545ls Tractor (registration GX12 KCG), left the scene without the driver leaving any Driving Licence or Insurance details<sup>10</sup>.

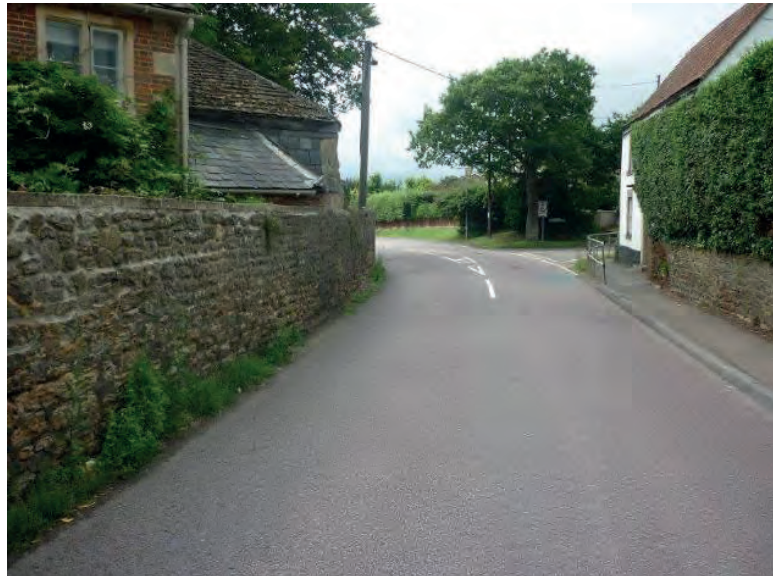
**Figure 16 - Approaching the 'pinch point' from the East**

It is noted that the road is too narrow for a lorry and a car (or another lorry) to pass together at this point (width 4.9 metres) without one of the vehicles having to mount the pavement endangering pedestrians.

The railings (that have been frequently damaged) in the bottom-right picture indicate the entrance to School Lane. This is the route to school for children and their parents.

If an HGV or bus driver cannot see 59m to an oncoming vehicle at the 'pinch point' (see 2.4.2.2) then the geometry fails at a very basic level. Even if they *can* see that far, reference to the Highway Link Design Manual of the Highways Agency indicates that the distance should be 65m, this being almost a rural road with a low alignment constraint (Ac) apart from at the 'pinch point'.

Safety measures at the 'pinch point' are therefore required, whether they embrace an introduction of a 20 mph limit in this area or a solution as outlined in Section 11 (Recommendations).

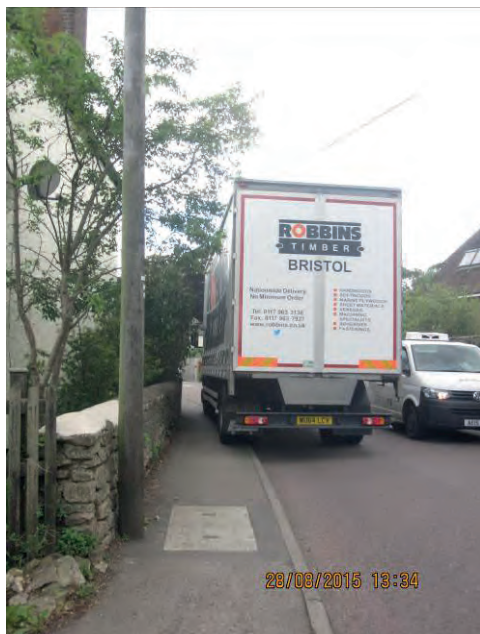
Figure 17 – ‘pinch point’ pavement

Figure 17 illustrates HGV dangers to pedestrians at the ‘pinch point’.

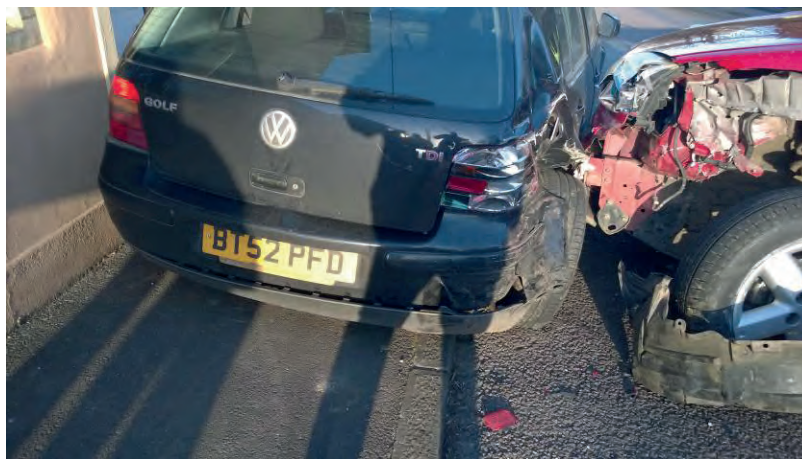
**Figure 20 - March 2015 – Collision**

*He lifted it onto the pavement and pushed it 15ft down the road! How fast must he have been going to achieve that??*

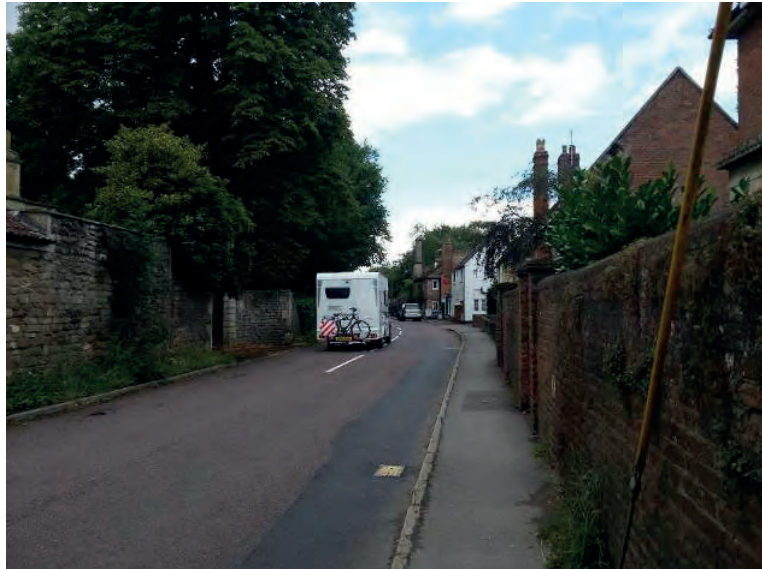
Figure 21 - Crossing to the Church (Looking West)

Figure 21 and Figure 22 show the views (East and West) that can be expected from pedestrians attempting to cross to the Church.

It should be noted that the road and footpaths here are narrow and even light vehicles such as the campervan in Figure 21 are crossing the centre road markings, thus pushing oncoming vehicles towards the footpath next to the opposite lane. The visibility splay dimensions are way below desirable standards for pedestrians at this point.

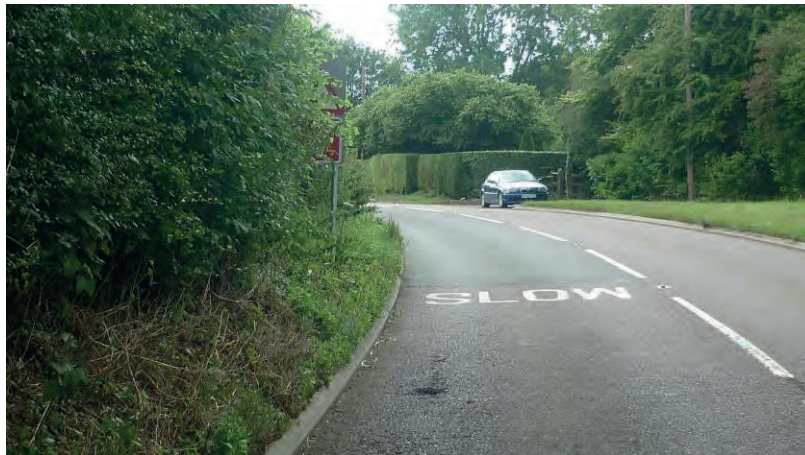
Figure 31 - Approaching the bends by Inmarsh Lane

Figure 31 shows hidden signposting as you approach Inmarsh Lane on the left entering the bends at the Eastern approach to the High Street.
