SEEND ROAD SAFETY INITIATIVE

(Version 2.1 – February 2017)

Seend Traffic – A361 in 2016

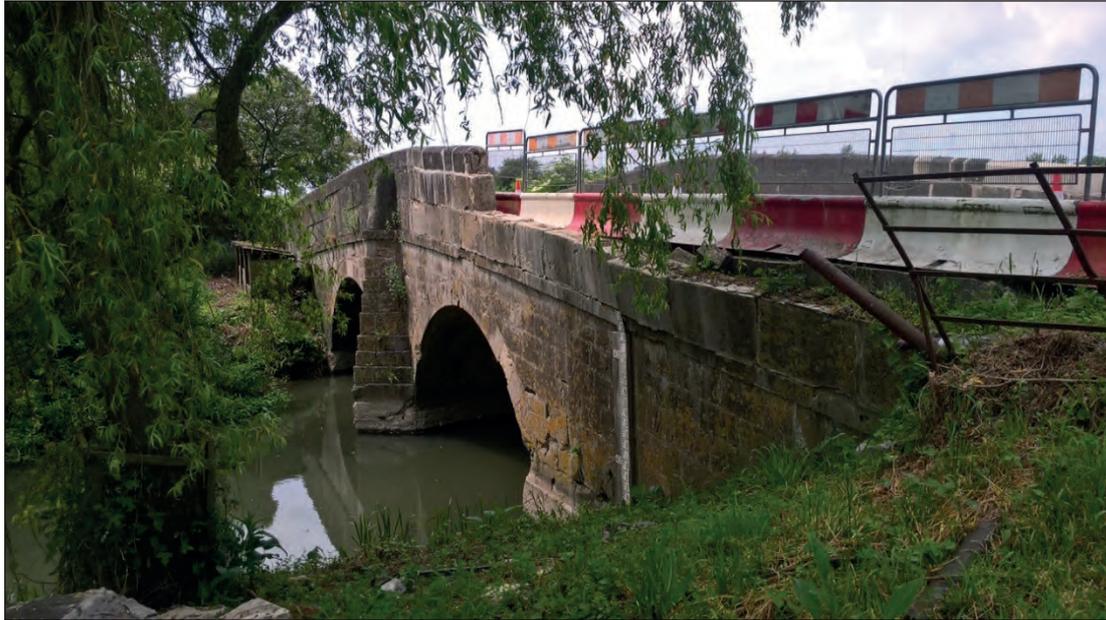
Figure 6 - Damage to Grade II listed Baldham Bridge - Under Repair (1)

This structure (Grade II listed) has been the victim of substantial and frequent damage over a number of years. Despite this, the authorities have deemed the bridge capable of handling the current freight traffic levels and further action, in respect to weight/speed limits on the bridge has been ruled out by Wiltshire Council.

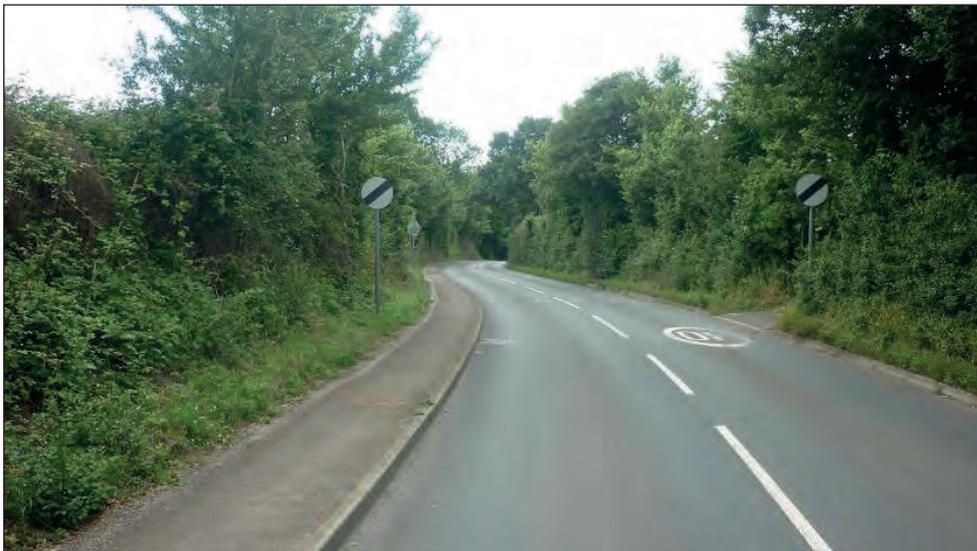
Figure 9 - Looking North-west towards the top of Bollands Hill

Having crossed the A361 from Bell Hill, heading North towards the A365, a left-hand bend is followed shortly by a very dangerous right hand bend (Bollands Hill) with no 30 mph speed limit continuing in operation.

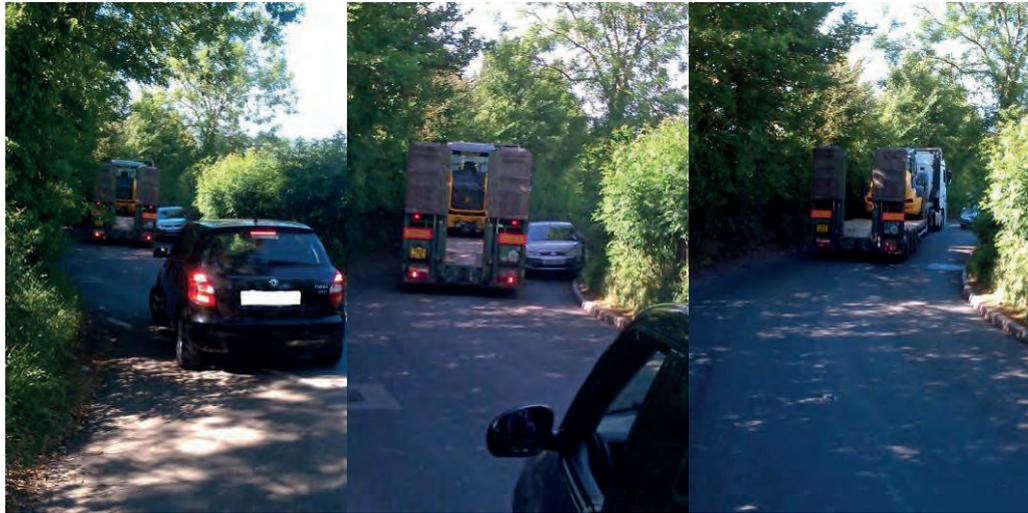
Figure 10 - Bollands Hill Blocked to Traffic

The lorry, a white 2012 Mercedes Actros 2545ls Tractor (registration GX12 KCG), left the scene without the driver leaving any Driving Licence or Insurance details¹⁰.

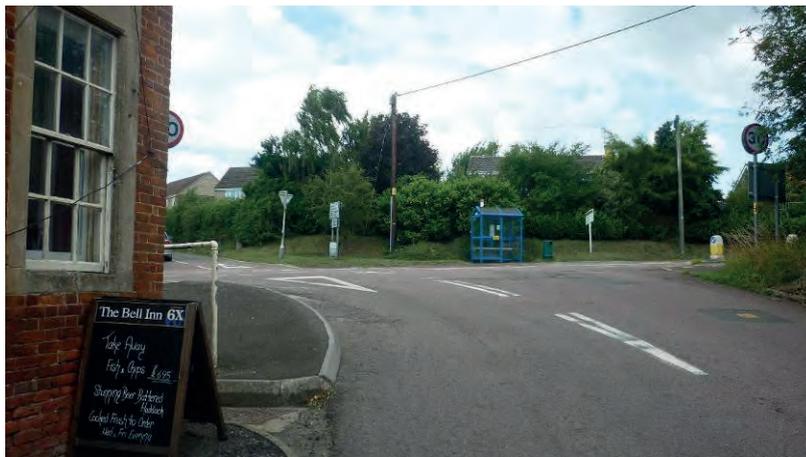
Figure 12 - Bell Hill crossroads (Approached from the South)

The approach to the cross-roads is a particularly good example of where the signs are woefully inadequate. Several recent accidents have occurred here (see Figure 12 - Bell hill crossroads (Approached from the South)).

The 30mph speed limit warning signs are sited 22 ft. from the A361 and only become visible when a motor vehicle is within 70 ft. of this main road.

At least two accidents have been caused within the last 6 months as a result of vehicles failing to stop in time as they approach the main road.

Attention to the sign deficiency highlighted at the Bell Hill cross roads and Bollands Hill.

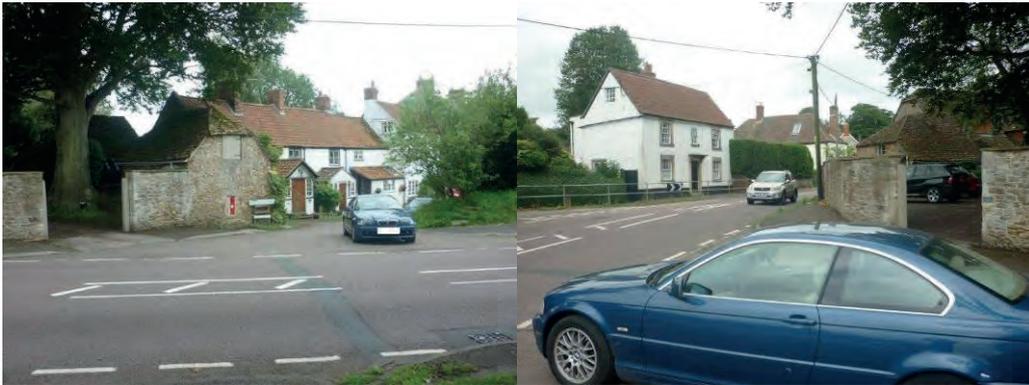
Figure 13 - Exiting from Weavers Cottages

Whereas entry to the road can be, at best, difficult, exiting from Weavers Cottages is hazardous: particularly if vehicles are exiting the ‘pinch point’ with vehicles approaching from the East at anything above 30mph with a stopping distance of 75 feet or more. The visibility to the East at this exit is 70 feet. Opening the driver side window and listening for oncoming traffic is an essential requirement.

It should also be noted that there are a number of other junctions in close proximity (the closest being the junction with School Lane) and therefore these also need to be considered when attempting to access the A361 at this point.

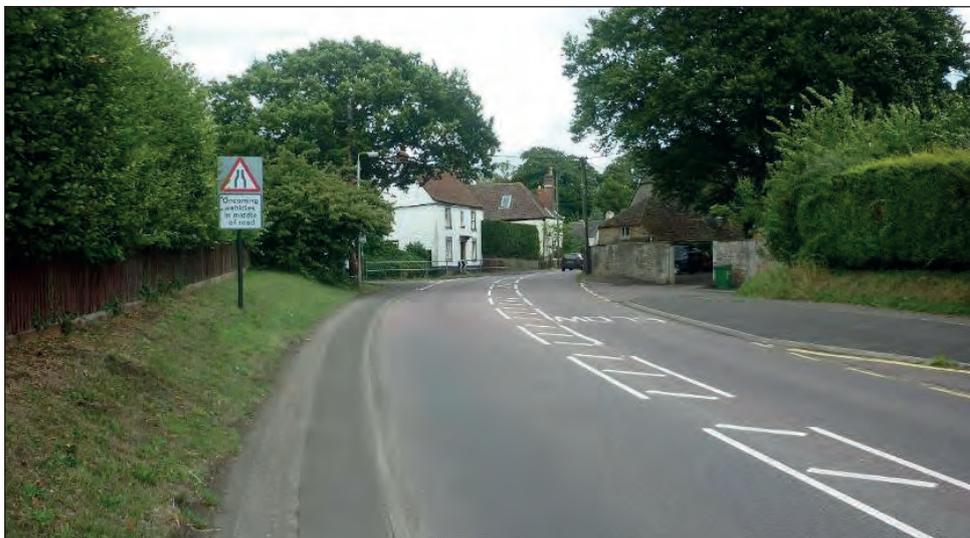
Figure 14 - Approaching from the West

Figure 14 shows the view when entering Seend, travelling East on the A361, from Trowbridge. The ‘pinch point’ is where the railings are visible on the left. This narrow footpath is the regular route for pupils from the village to reach the school.

On the right are Weavers Cottages where vehicles leaving to join the A361 have less than 70 feet of visibility from the East.

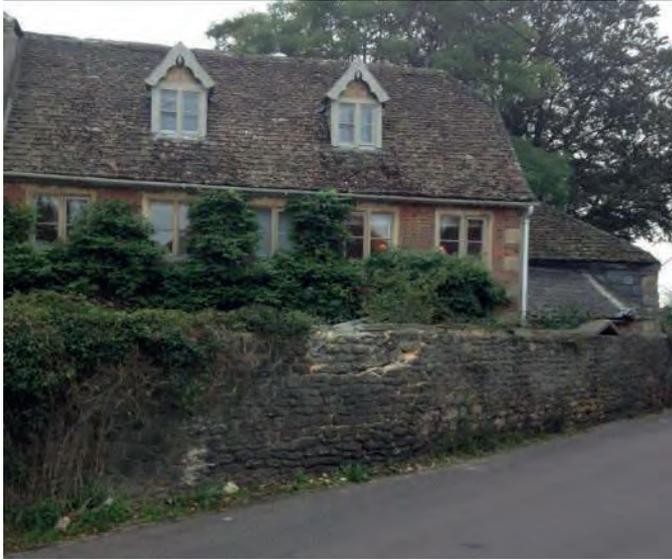
Figure 15 - Damaged wall at the 'pinch point'

A juggernaut has hit our garden wall which faces onto High Street, Seend!!

A white van also crashed into the wall a month before at 4am causing damage.

Luckily no one was hurt but both incidents were caused by a juggernaut meeting a car / van at the pinch point near our house. If the van had been another large lorry it could have had the weight to knock the wall over, possibly injuring or killing the driver, and if it had been in the daytime injuring or killing someone in my family as the wall backs right onto our garden.

The ‘pinch point’ is a particularly hazardous location at the West end of the High Street.

Although it acts as a natural traffic calming point, the speed at which vehicles approach this road restriction means that making contact with each other, or the wall/railings to either side highly likely. This may result in damage to the vehicles, residential property, roadside furniture or, in the worst possible case, death or injury.

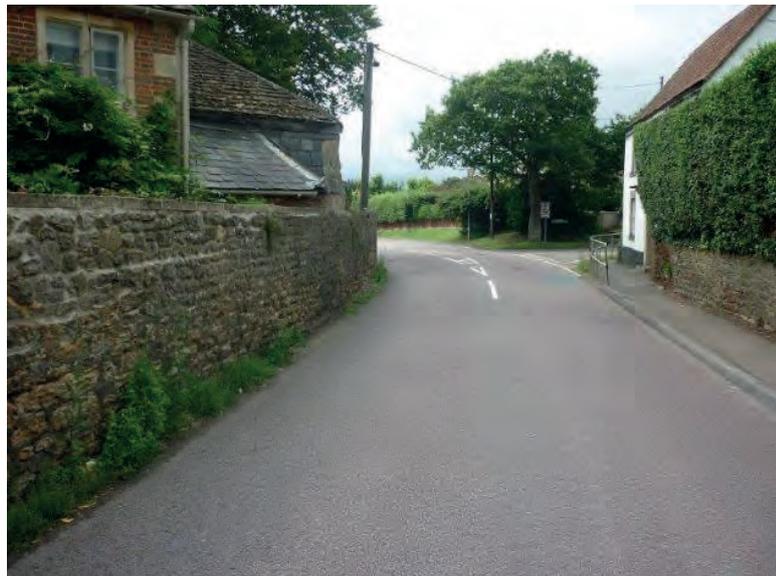
Figure 16 - Approaching the 'pinch point' from the East

It is noted that the road is too narrow for a lorry and a car (or another lorry) to pass together at this point (width 4.9 metres) without one of the vehicles having to mount the pavement endangering pedestrians.

The railings (that have been frequently damaged) in the bottom-right picture indicate the entrance to School Lane. This is the route to school for children and their parents.

If an HGV or bus driver cannot see 59m to an oncoming vehicle at the 'pinch point' (see 2.4.2.2) then the geometry fails at a very basic level. Even if they *can* see that far, reference to the Highway Link Design Manual of the Highways Agency indicates that the distance should be 65m, this being almost a rural road with a low alignment constraint (Ac) apart from at the 'pinch point'.

Safety measures at the 'pinch point' are therefore required, whether they embrace an introduction of a 20 mph limit in this area or a solution as outlined in Section 11 (Recommendations).

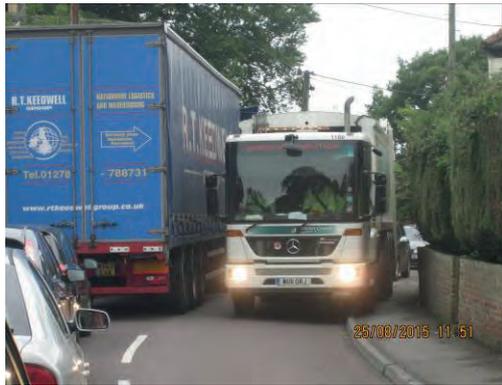
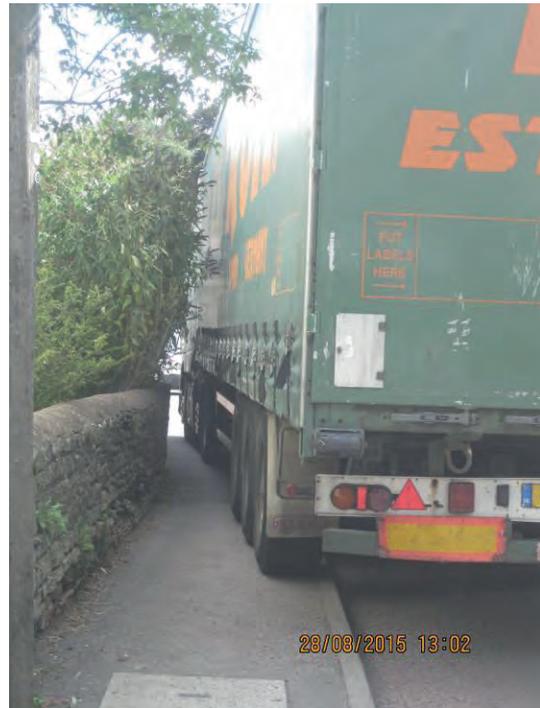
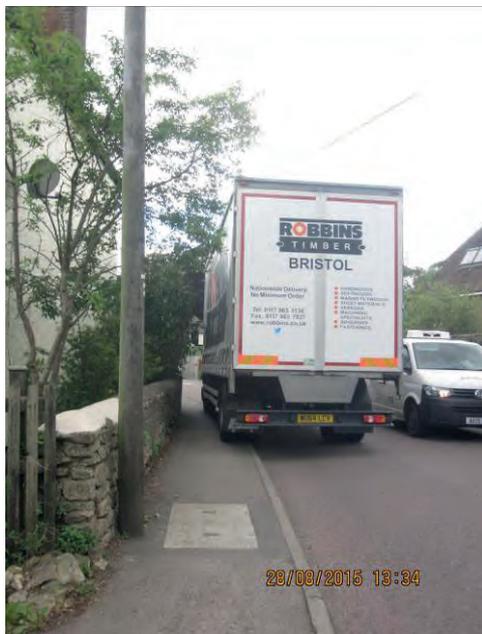
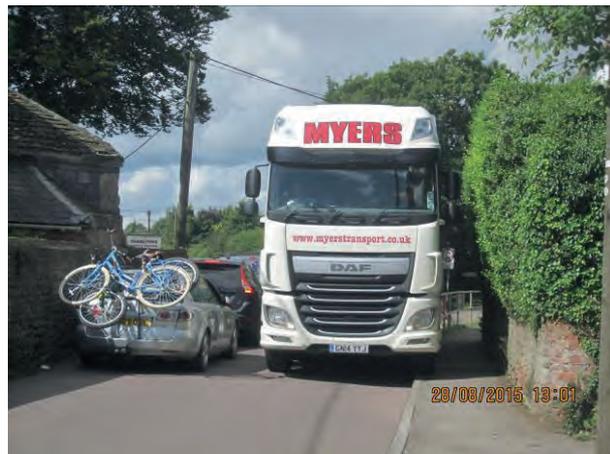
Figure 17 – ‘pinch point’ pavement

Figure 17 illustrates HGV dangers to pedestrians at the ‘pinch point’.

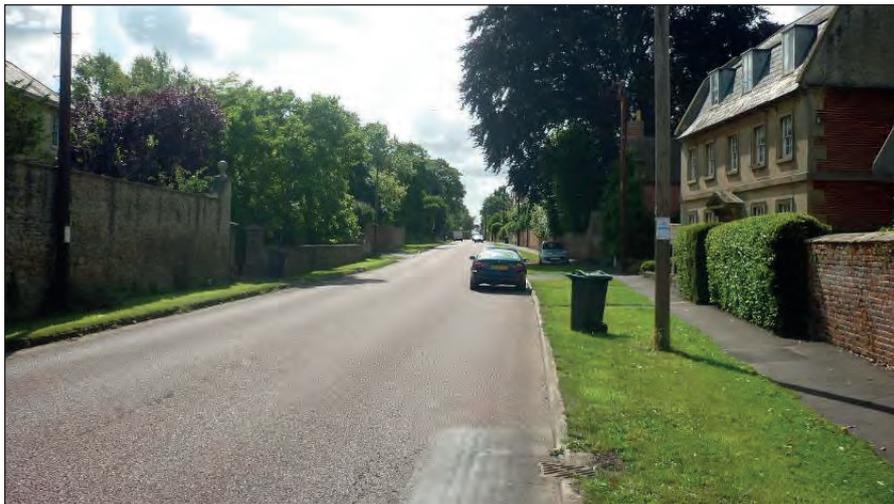
Figure 19 - Eastern end looking West

Figure 19 shows how inviting the three lane width of the High Street is to motorists leaving the bends at the top of the hill from Seend Fork: especially those that remain unaware of the 30mph zone.

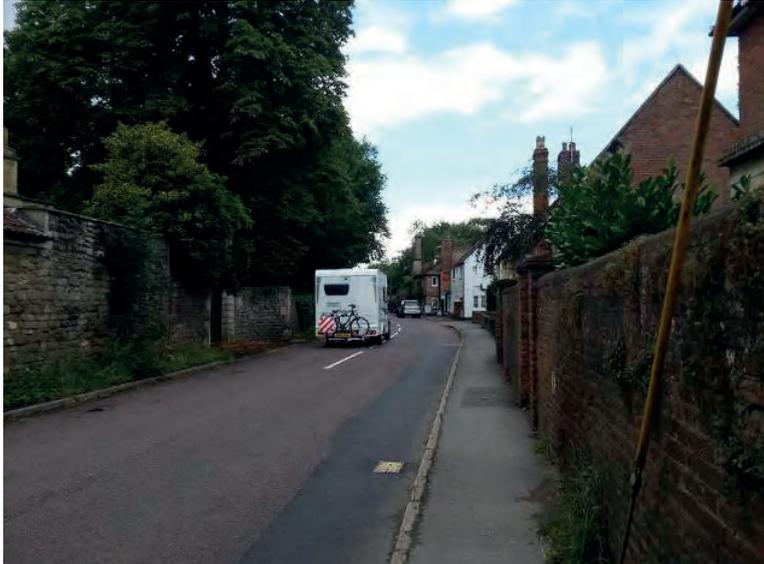
Figure 21 - Crossing to the Church (Looking West)

It should be noted that the road and footpaths here are narrow and even light vehicles such as the campervan in Figure 21 are crossing the centre road markings, thus pushing oncoming vehicles towards the footpath next to the opposite lane. The visibility splay dimensions are way below desirable standards for pedestrians at this point.

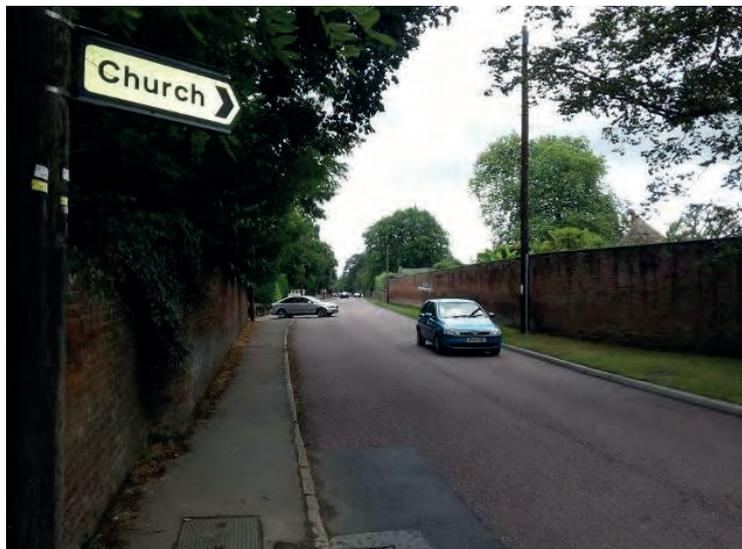
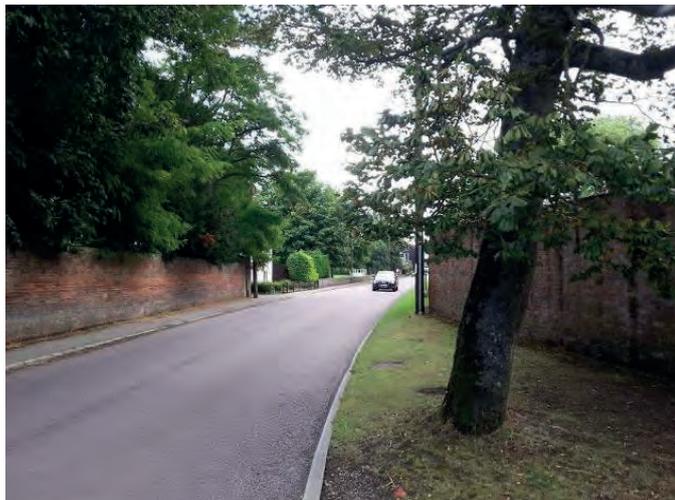
Figure 22 - Crossing to the Church – (Looking East)

Figure 22 and Figure 24 clearly show some of the obstacles that make the use of the grass verge on the South side of the High Street impractical.

There are no footpaths on the South side of the High Street and there are a number of obstacles (including signs and telegraph poles) that make the use of the narrow grass verge hazardous to pedestrians who might otherwise use this as a possibility to give them a better view of oncoming traffic. As previously stated, the visibility splays at this point are inadequate for pedestrians, as they also are for vehicles exiting Rusty Lane.

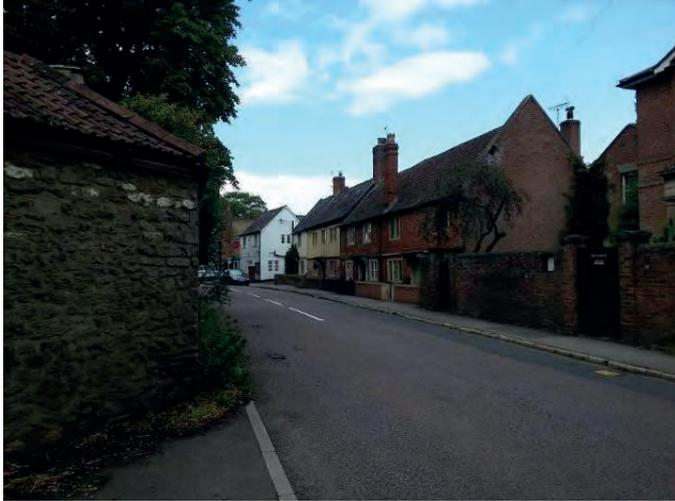
Figure 23 - From the Church (Looking West)

As can be seen, the view to the West is particularly hazardous as the view is shortened by the wall and the bend towards the Post Office.

It should be noted that the width of the road at this point is 6.1 metres.

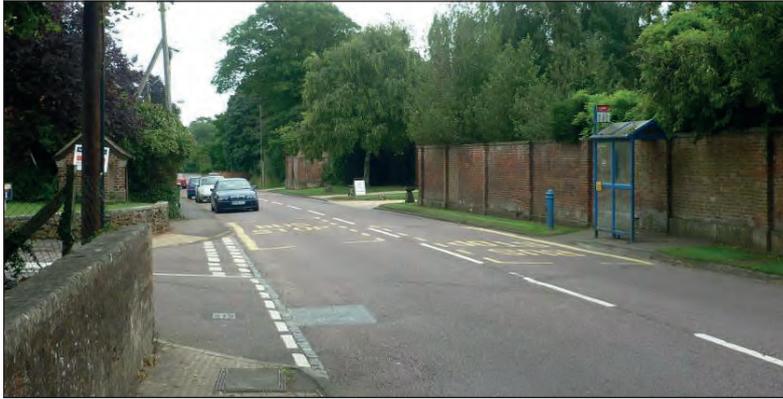
Figure 25 - The High Street Bus Stops

Two bus stops in the centre of High Street straddle the junction with The Lye.

It is also hazardous for drivers of cars trying to exit The Lye onto the High Street.

The location of the South side bus stop goes against good practice. If possible it should be relocated to the West with footway widening. See 11 Recommendations.

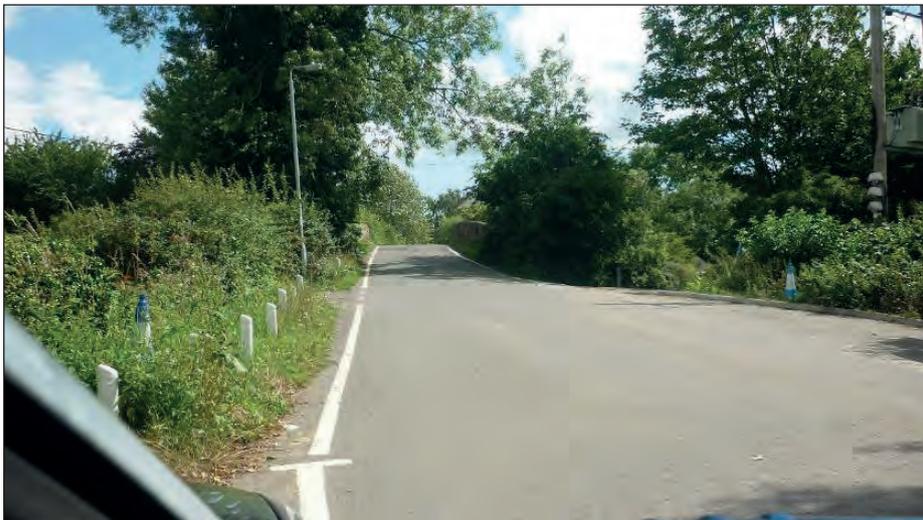
Figure 28 - Spout Lane Canal Bridge (from the North)

Figure 28 shows the view as you approach the canal bridge from the North. There are no speed restrictions or warning of the single carriageway.

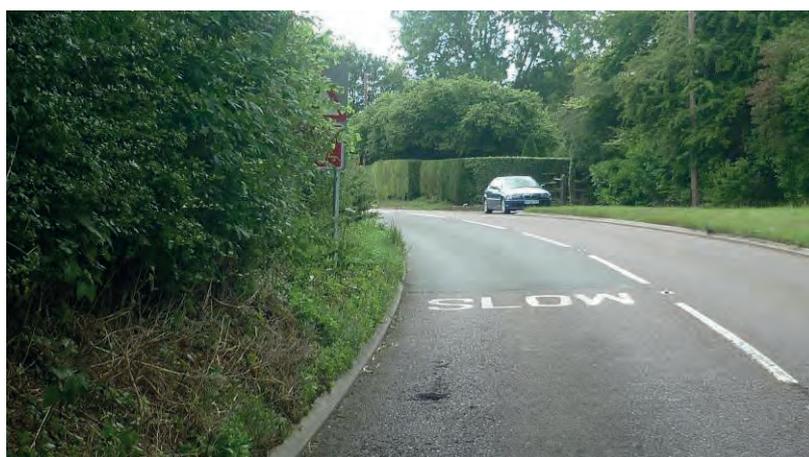
Figure 31 - Approaching the bends by Inmarsh Lane

Figure 31 shows hidden signposting as you approach Inmarsh Lane on the left entering the bends at the Eastern approach to the High Street.

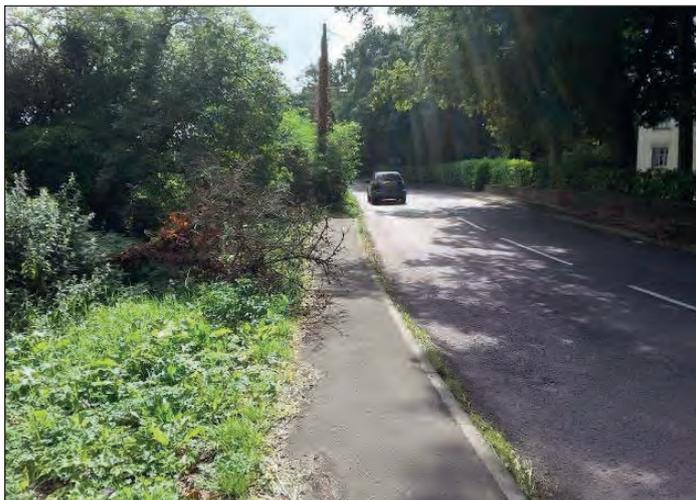
Figure 34 - The footpath looking East

Figure 34 shows the view of the footpath if walking from the village on the North side of the road and to the point that the path crosses to the South side. At the time the picture was taken the footpath has also been partially blocked by a fallen branch.

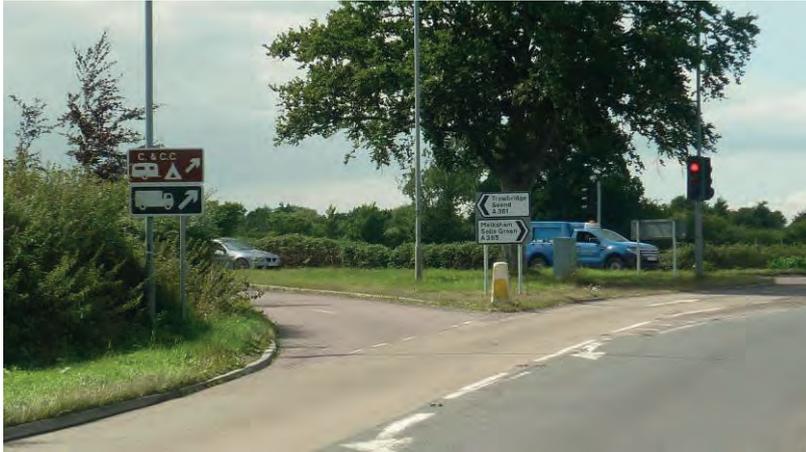
Figure 35 - Approaching Seend Fork from Devizes

Wiltshire Council (See section 11) signs situated on the A365 approaching Seend Fork are ineffective in directing HGVs in accordance with the Wiltshire Council Freight Route Policy. The signs at the traffic lights are confusing and the presence of a filter lane encourages traffic to turn left rather than wait at the traffic lights. Furthermore, two signs are contradictory, one routes HGVs to Westbury and Trowbridge via A365 and a later one signals traffic to Trowbridge through Seend Village via A361.
