SEEND ROAD SAFETY INITIATIVE

(Version 2.1 – February 2017)

Seend Traffic – A361 in 2016

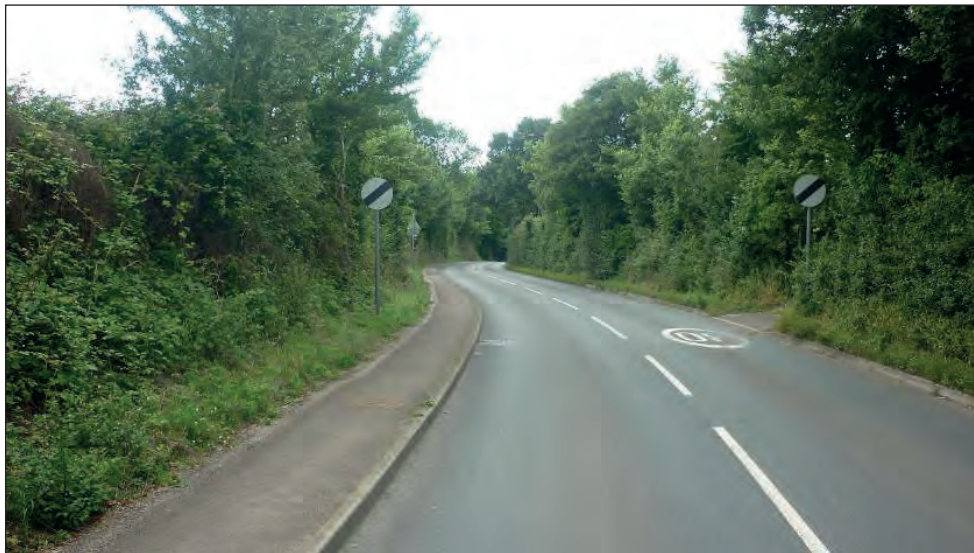
Figure 9 - Looking North-west towards the top of Bollands Hill

Having crossed the A361 from Bell Hill, heading North towards the A365, a left-hand bend is followed shortly by a very dangerous right hand bend (Bollands Hill) with no 30 mph speed limit continuing in operation.

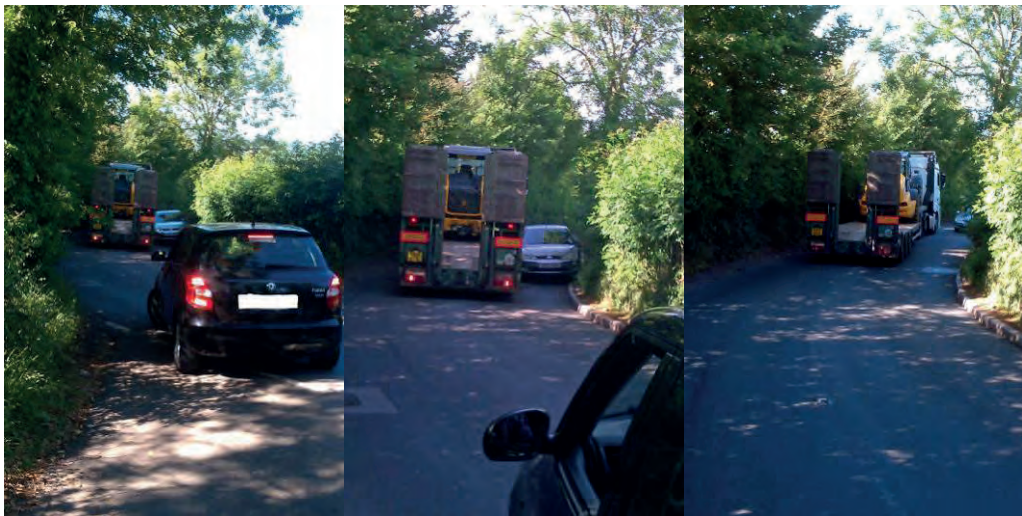
Figure 10 - Bollands Hill Blocked to Traffic

The lorry, a white 2012 Mercedes Actros 2545ls Tractor (registration GX12 KCG), left the scene without the driver leaving any Driving Licence or Insurance details¹⁰.

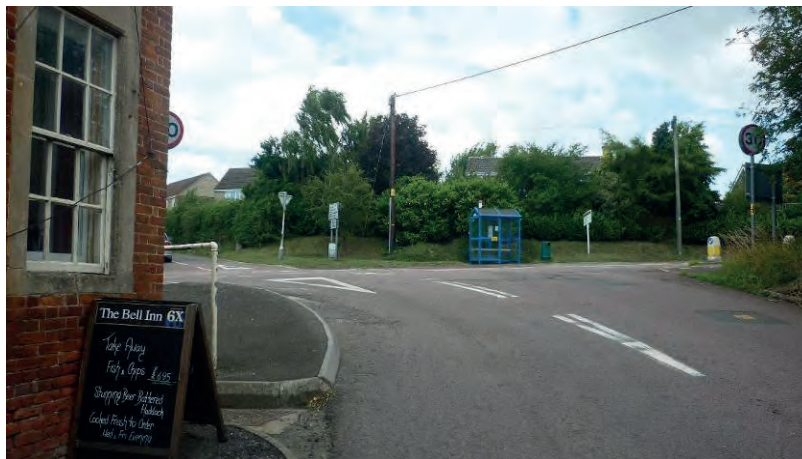
Figure 12 - Bell Hill crossroads (Approached from the South)

The approach to the cross-roads is a particularly good example of where the signs are woefully inadequate. Several recent accidents have occurred here (see Figure 12 - Bell hill crossroads (Approached from the South)).

The 30mph speed limit warning signs are sited 22 ft. from the A361 and only become visible when a motor vehicle is within 70 ft. of this main road.

At least two accidents have been caused within the last 6 months as a result of vehicles failing to stop in time as they approach the main road.

Attention to the sign deficiency highlighted at the Bell Hill cross roads and Bollands Hill.

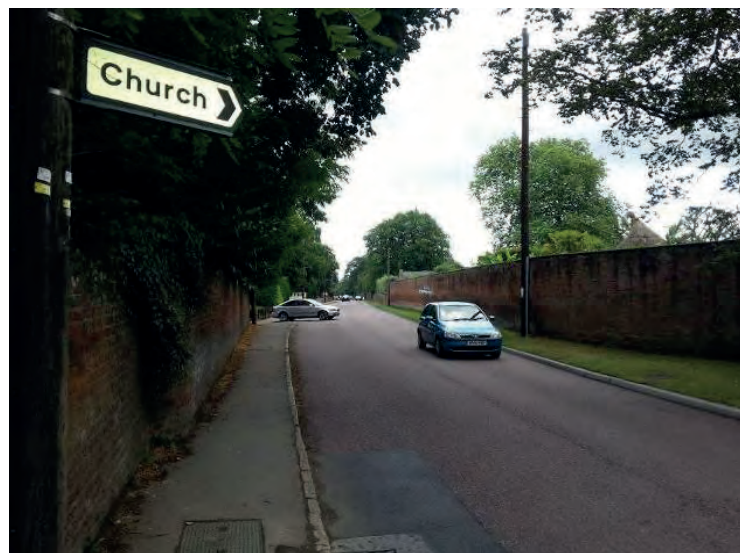
Figure 22 - Crossing to the Church – (Looking East)

Figure 22 and Figure 24 clearly show some of the obstacles that make the use of the grass verge on the South side of the High Street impractical.

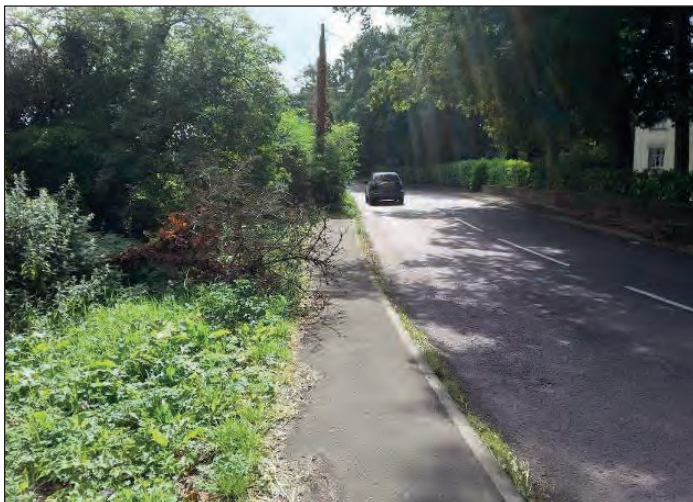
Figure 34 - The footpath looking East

Figure 34 shows the view of the footpath if walking from the village on the North side of the road and to the point that the path crosses to the South side. At the time the picture was taken the footpath has also been partially blocked by a fallen branch.
