# SEEND ROAD SAFETY INITIATIVE

(Version 2.1 – February 2017)

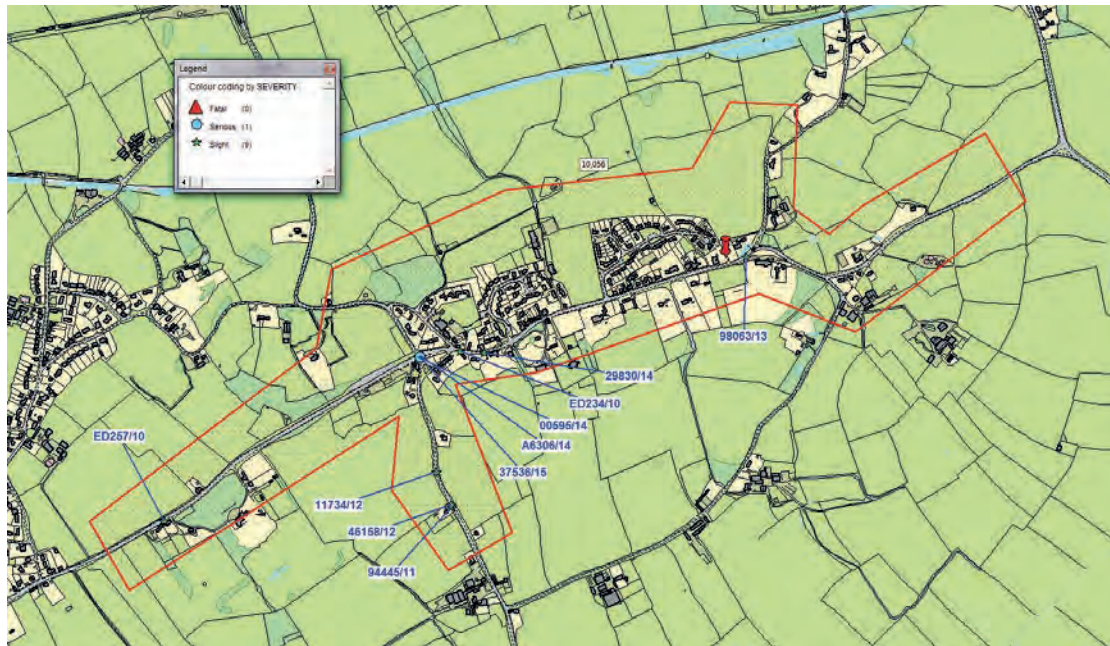
Figure 2 - Road Traffic Injury Collisions – 01/05/2010 to 30/04/2015

Figure 2 shows the positions of the collisions. **Note.** None of the examples contained in this document are shown in these statistics.

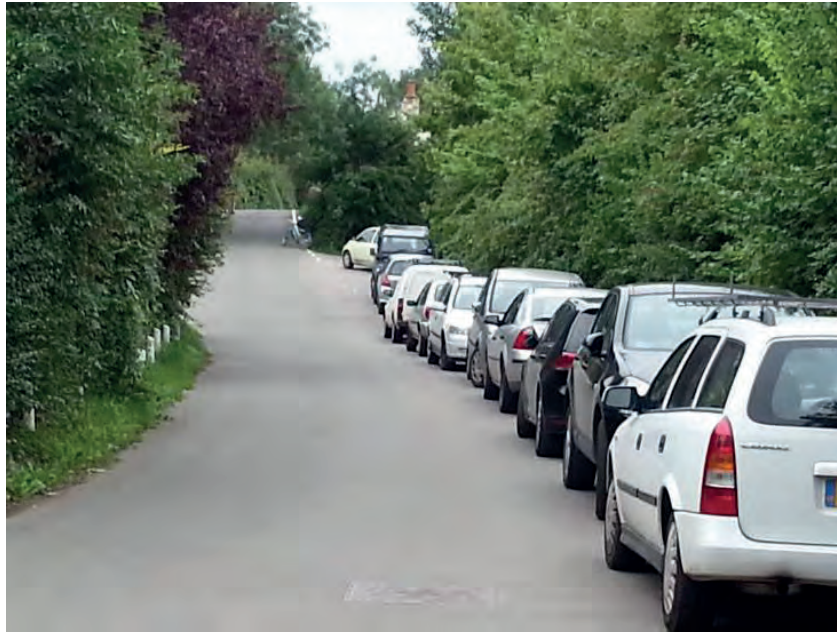
**Figure 29 - Spout Lane (from the North)**

Spout Lane continues to be an “unrestricted” route along its entire route, despite:

<sup>12</sup> Figure 29 shows a young child pushing their bicycle across the road by the bridge and completely invisible to vehicles approaching from the other side of the bridge.

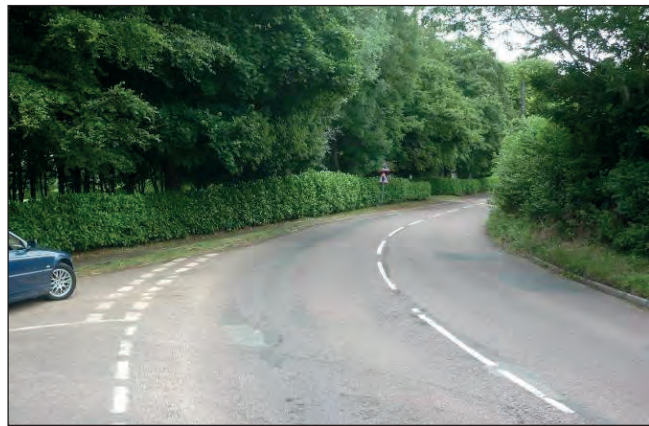
Figure 33 - Looking East from the entrance to Inmarsh Lane

Once in the bends you will notice that the footpath switches from the South side of the road (visible in Figure 33) to the North side of the road.

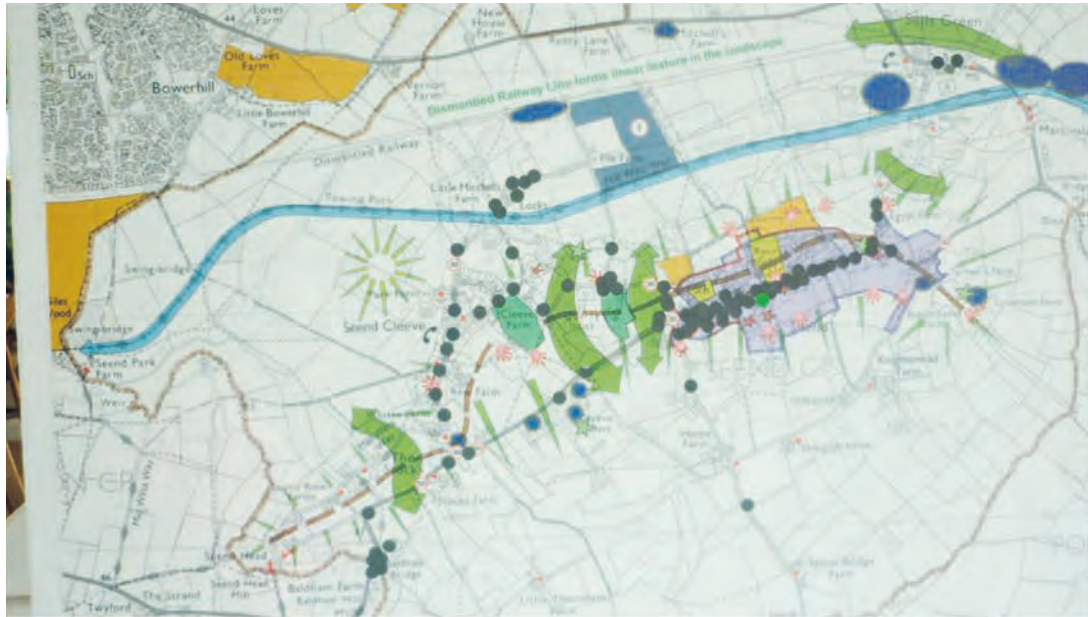
**Figure 36 - Heat Map (Volume of Traffic)**

**VOLUME OF TRAFFIC** High Street, Bolland's Hill and Baldham Bridge are all areas of major concern with local issues at School Lane during term time and Spout lane in the morning rush hour. Particular opinions are expressed over car parking giving local difficulties at the Post Office, Stocks, Canal (C20 and New Buildings) and School Lane.

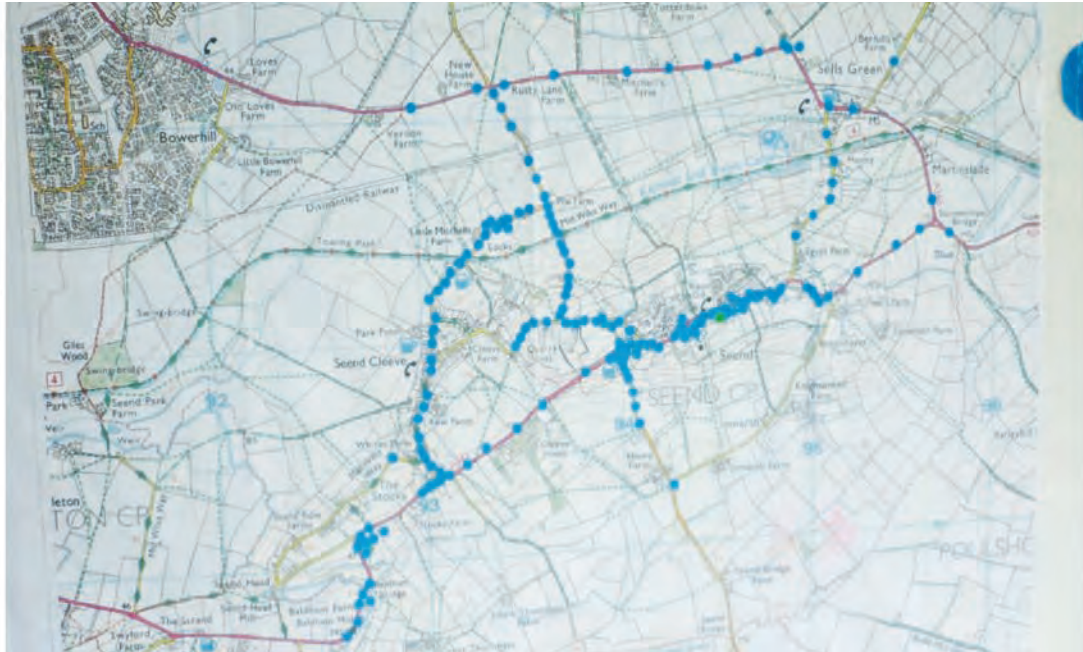
Figure 37 - Heat Map (Excessive Speed)

SUMMARY - An extension of 30 mph speed restrictions and law enforcement within the Parish is clearly indicated. Traffic calming measures are also required

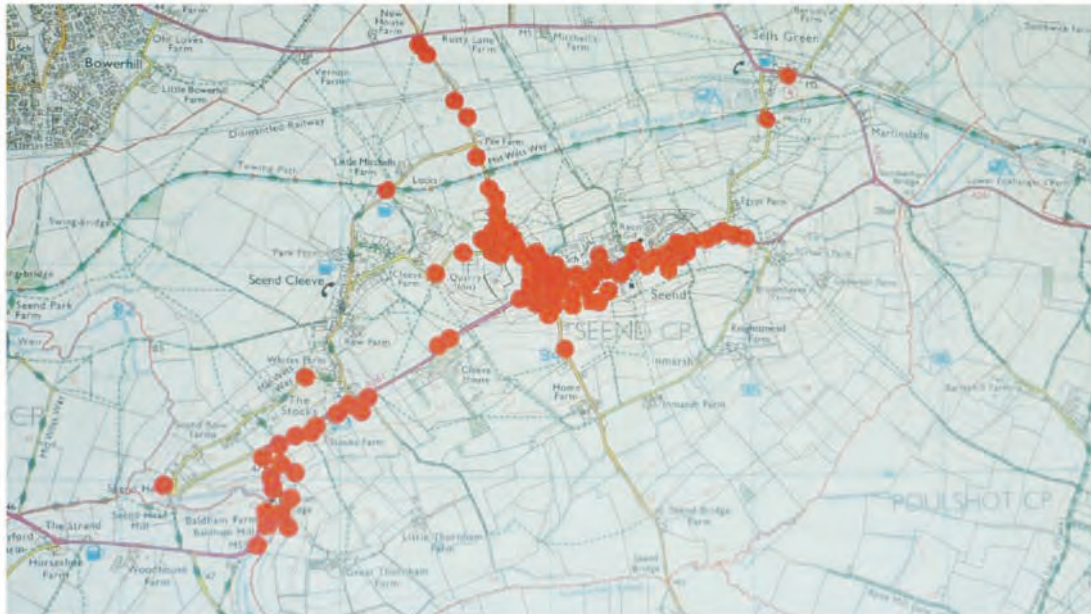
Figure 38 - Heat Map (HGVs)

The validity of the Local Lorry Route status of the A365 impacting upon the volume of HGV traffic using the A361 through the High Street both day and night needs remedial action.
