# SEEND ROAD SAFETY INITIATIVE

(Version 2.1 – February 2017)

Seend Traffic – A361 in 2016

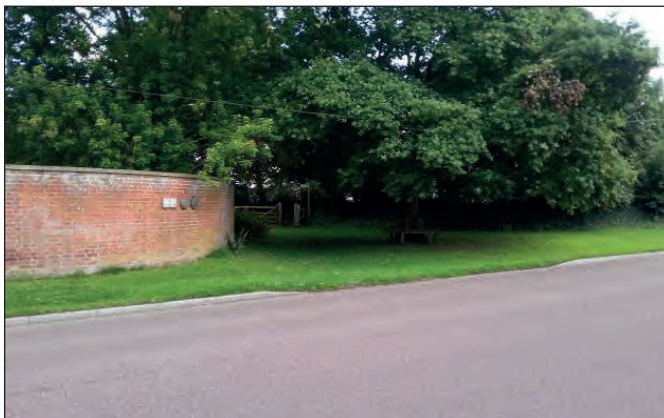
**Figure 26 - Love Walk**

It provides an access point to the public footpath that runs parallel to the High Street (on the South side), linking the churchyard and the junction between Inmarsh Lane and the A361 (See section 8.2). It also provides a route down the hill to the bottom of Inmarsh lane
