SEEND ROAD SAFETY INITIATIVE

(Version 2.1 – February 2017)

Seend Traffic – A361 in 2016

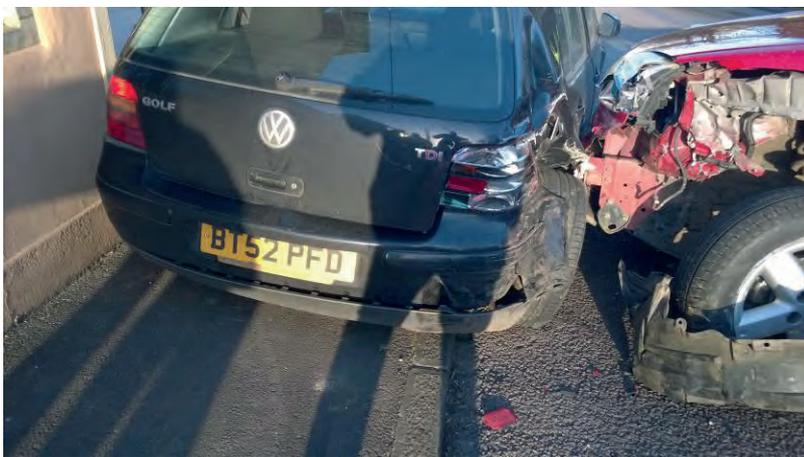
Figure 20 - March 2015 – Collision

He lifted it onto the pavement and pushed it 15ft down the road! How fast must he have been going to achieve that??

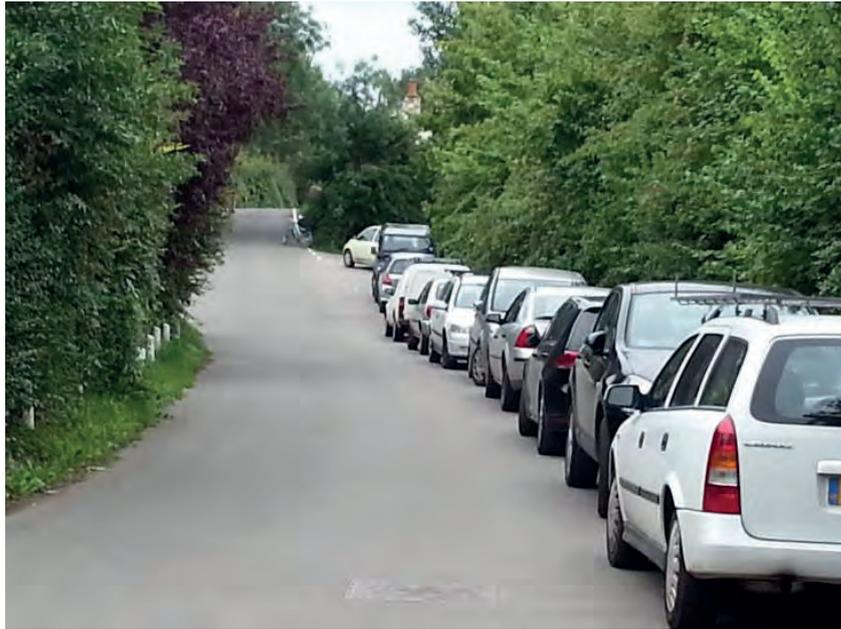
Figure 29 - Spout Lane (from the North)

¹² Figure 29 shows a young child pushing their bicycle across the road by the bridge and completely invisible to vehicles approaching from the other side of the bridge.

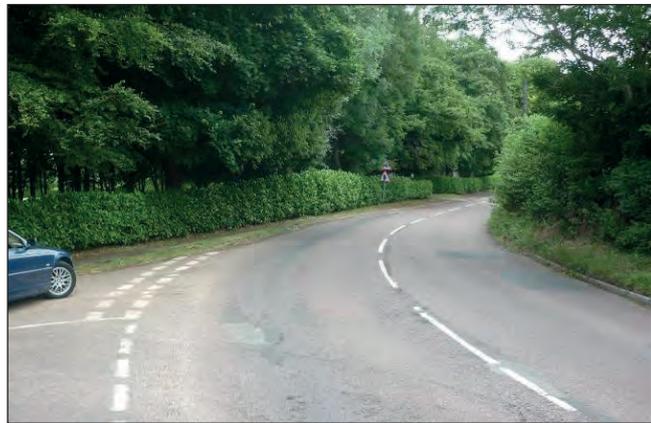
Figure 33 - Looking East from the entrance to Inmarsh Lane

Once in the bends you will notice that the footpath switches from the South side of the road (visible in Figure 33) to the North side of the road.

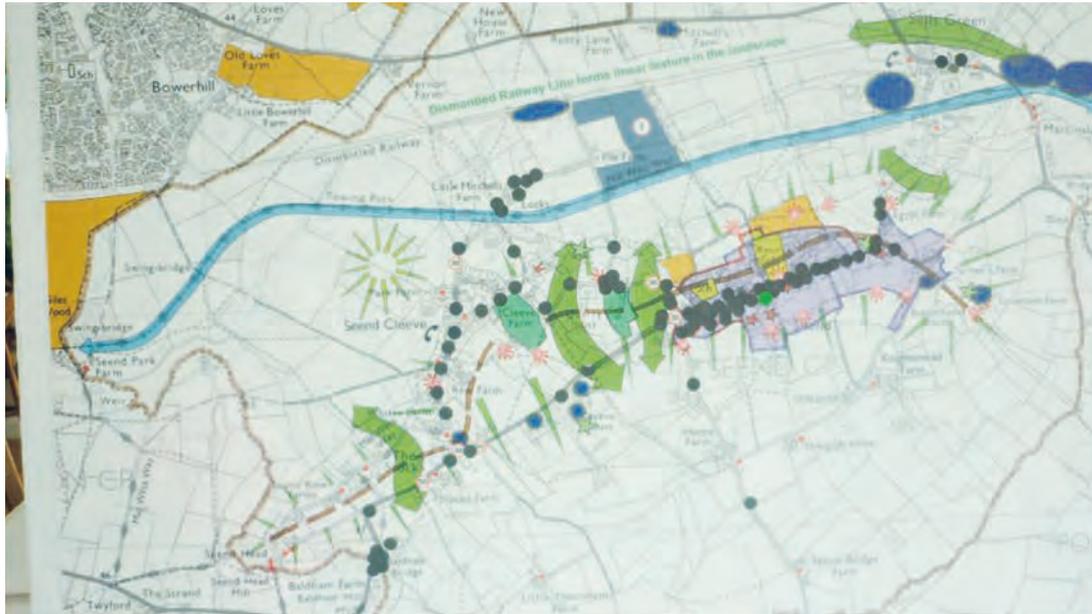
Figure 36 - Heat Map (Volume of Traffic)

VOLUME OF TRAFFIC High Street, Bolland's Hill and Baldham Bridge are all areas of major concern with local issues at School Lane during term time and Spout lane in the morning rush hour. Particular opinions are expressed over car parking giving local difficulties at the Post Office, Stocks, Canal (C20 and New Buildings) and School Lane.

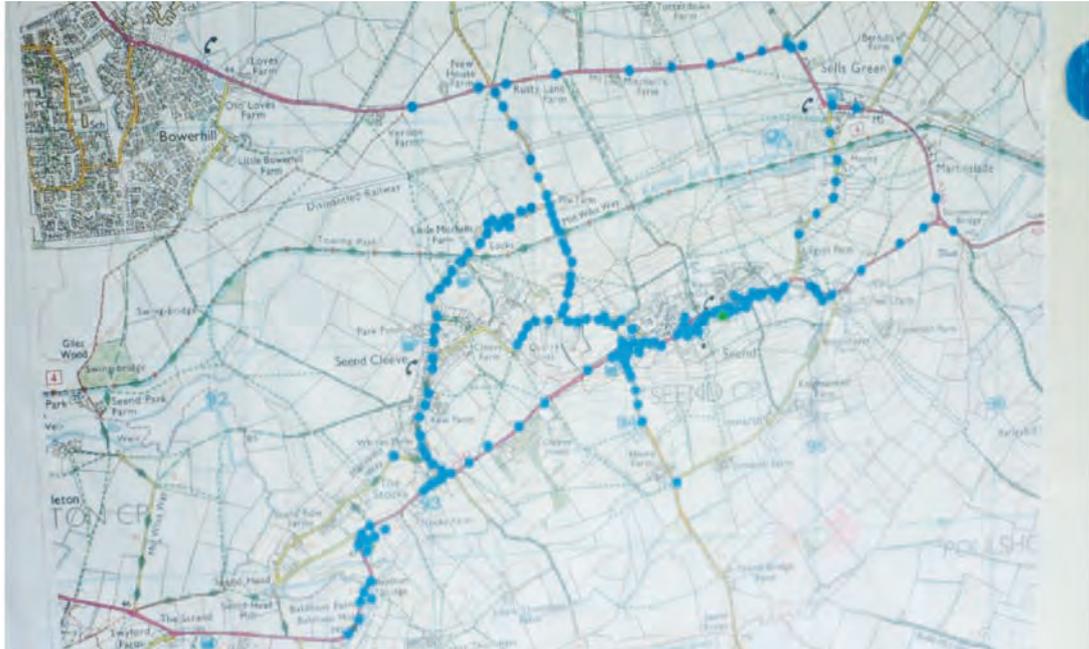
Figure 37 - Heat Map (Excessive Speed)

Seend High Street (38)

SUMMARY - An extension of 30 mph speed restrictions and law enforcement within the Parish is clearly indicated. Traffic calming measures are also required

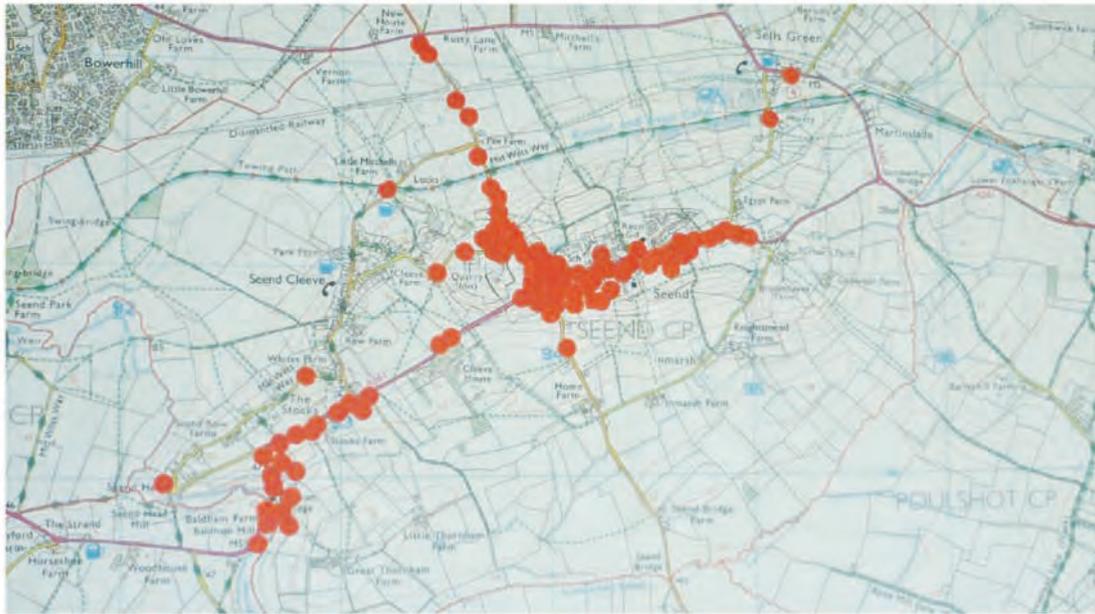
Figure 38 - Heat Map (HGVs)

High Street (inc. Bell Hill x-Roads) (55)

The validity of the Local Lorry Route status of the A365 impacting upon the volume of HGV traffic using the A361 through the High Street both day and night needs remedial action.
