SEEND ROAD SAFETY INITIATIVE

(Version 2.1 – February 2017)

Seend Traffic – A361 in 2016

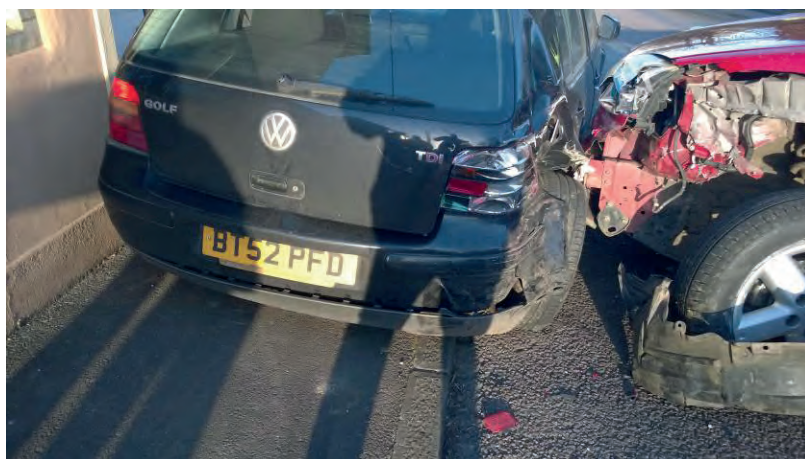
Figure 20 - March 2015 – Collision

He lifted it onto the pavement and pushed it 15ft down the road! How fast must he have been going to achieve that??

There are no traffic calming measures incorporated into the design of the High Street: nor are there any pedestrian crossings or refuges to provide safety whilst crossing this busy road.

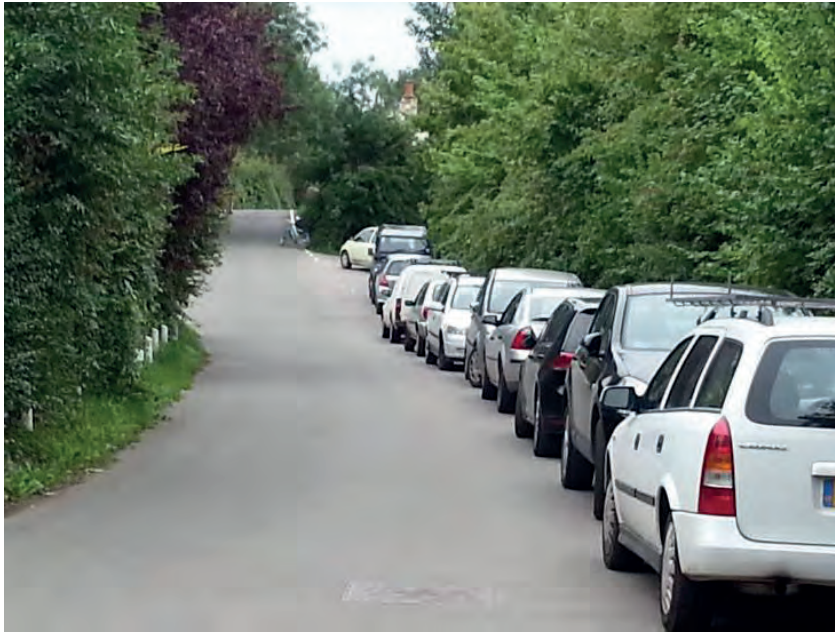
Figure 29 - Spout Lane (from the North)

Spout Lane continues to be an “unrestricted” route along its entire route, despite:

¹² Figure 29 shows a young child pushing their bicycle across the road by the bridge and completely invisible to vehicles approaching from the other side of the bridge.

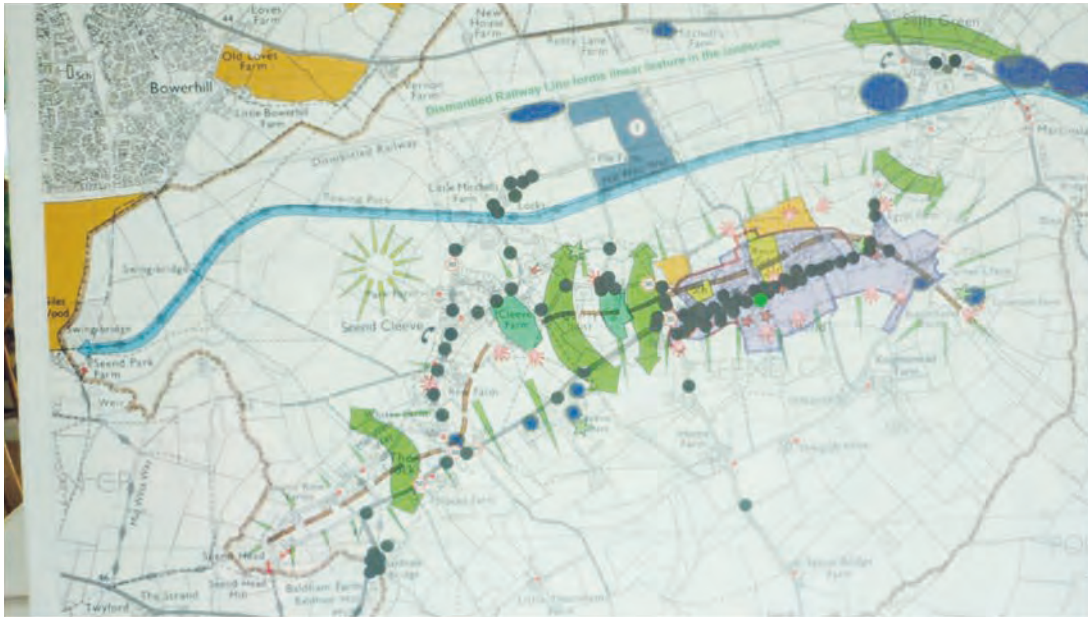
Figure 36 - Heat Map (Volume of Traffic)

VOLUME OF TRAFFIC High Street, Bolland's Hill and Baldham Bridge are all areas of major concern with local issues at School Lane during term time and Spout lane in the morning rush hour. Particular opinions are expressed over car parking giving local difficulties at the Post Office, Stocks, Canal (C20 and New Buildings) and School Lane.

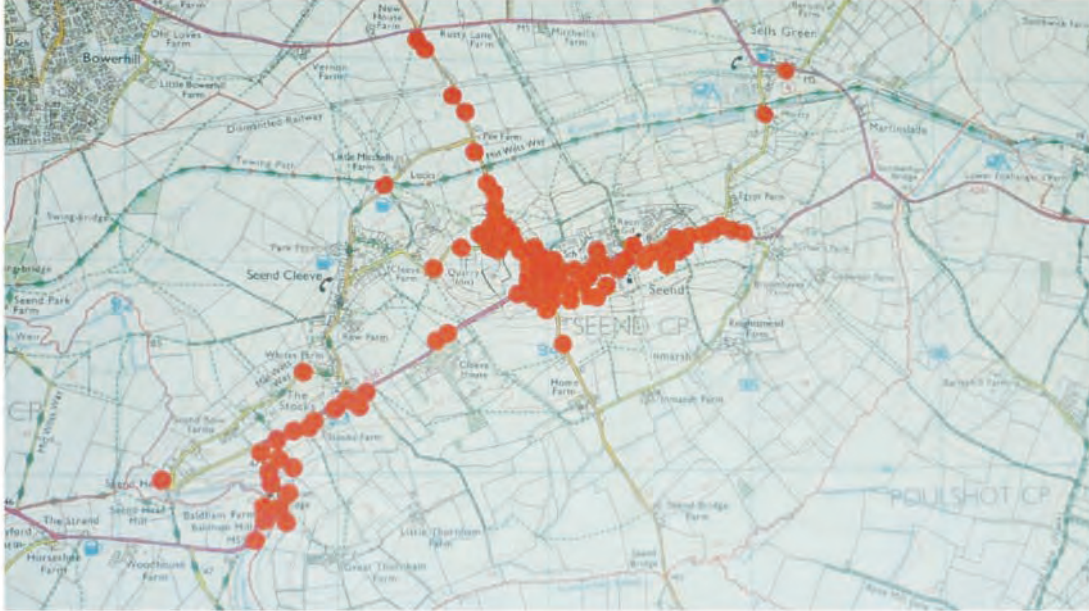
Figure 38 - Heat Map (HGVs)

High Street (inc. Bell Hill x-Roads) (55)

The validity of the Local Lorry Route status of the A365 impacting upon the volume of HGV traffic using the A361 through the High Street both day and night needs remedial action.

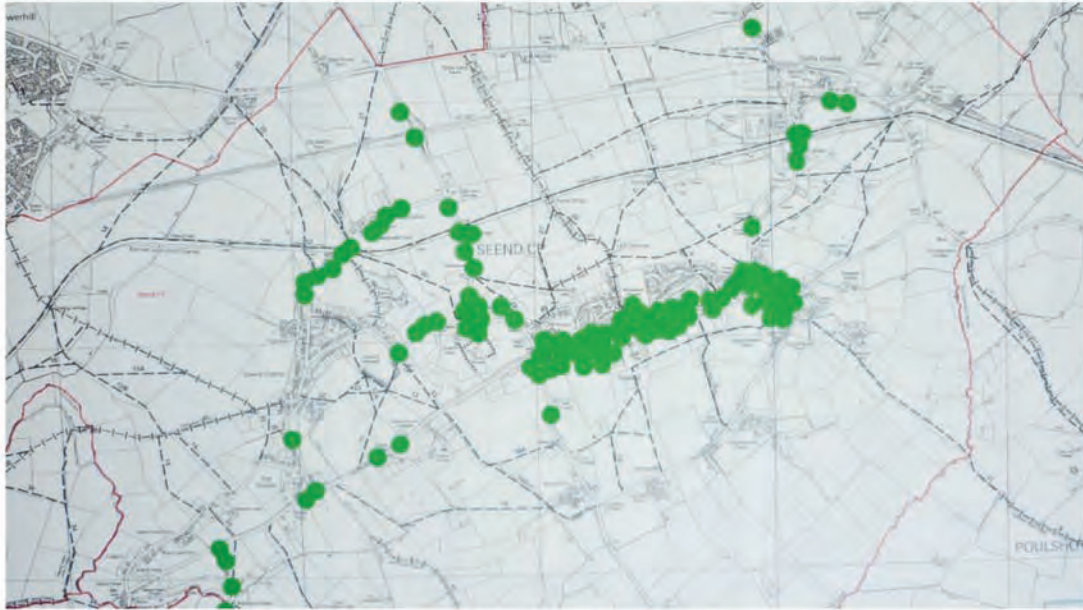
Figure 39 - Heat Map (As a Non-Driver)

Pedestrian Safety (87)
